Congressional Testimony and the Deepwater Horizon Oil Spill

Posted by [Heading Out](#) on May 13, 2010 - 10:55am

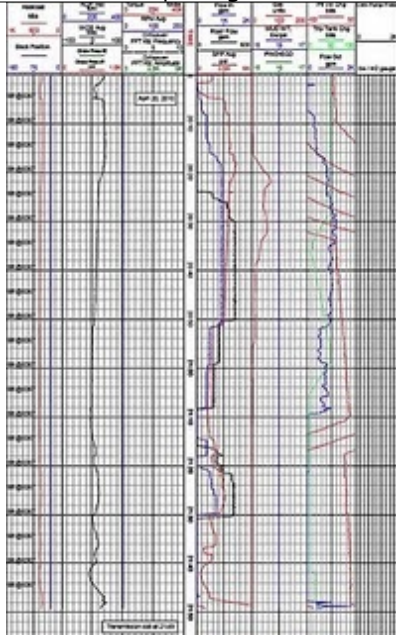
Halliburton provided the [well log for the last two hours](#) of the rig operation

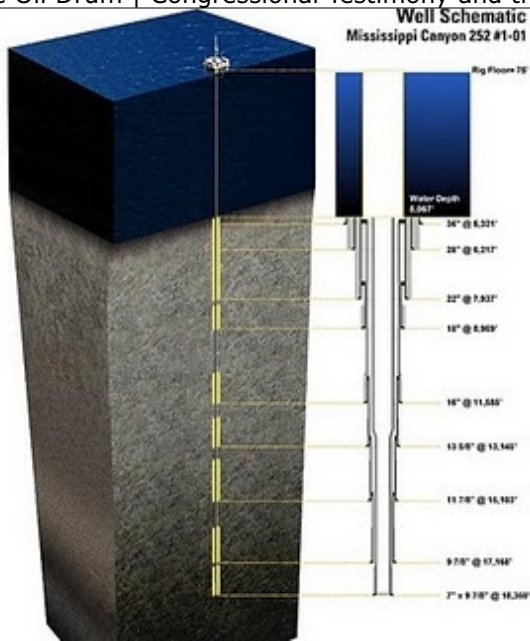
He showed a schematic of the well showing the intervals that were cemented, and the stages of casing down the well.

It was interesting to note that he stressed that the well was not fully cemented over its full length, but

It should be noted that cement is used at specific designated spots and is not designed to be a complete barrier through the entire wellbore.
