What caused the Deepwater Horizon disaster?

Posted by [aeberman](#) on May 21, 2010 - 8:28am

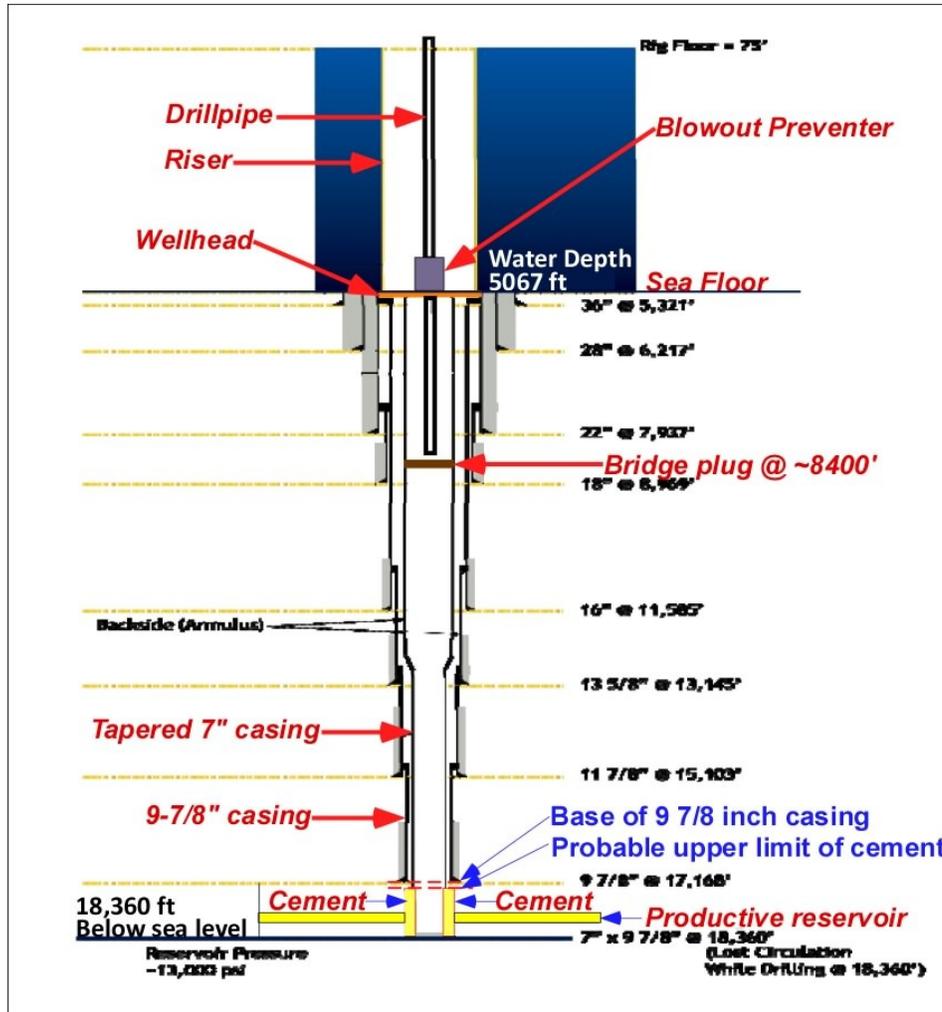
1. The well had reached a depth of 13,293 ft below the sea floor. The final string of production casing from the wellhead at the sea floor to total depth had been put in the hole, and cemented in place on April 19, 2010.
2. Only 51 barrels of cement were used according to the well plan. This was not sufficient to ensure a seal between the 7-inch production casing and the previously cemented 9 7/8-inch protection casing (Figure 2).

Figure 2. Mississippi Canyon Block 252 well schematic diagram (modified from www.tudorpickering.com/pdfs/tph.well.slides.pdf).

3. Mud had been lost to the reservoir while drilling the bottom portion of the well (this is called "lost circulation"). It usually indicates good reservoir quality, an interval of lower pressure or both, and can result in an enlarged wellbore or "washout". The significance of this is that it might have been difficult to create a good cement seal between the casing and the formation. It also would have been impossible to ensure the effectiveness of the cement seal without running a cement-bond log, and this was not done.

4. The cement contained a nitrogen additive to make it lighter so that it would flow more easily and better fill the area between the casing and the lost circulation-washout zone. This also may have decreased its sealing effectiveness. Gas from the reservoir may have further diluted the viscosity of the cement.

What can be addressed now is the larger issue that a flawed, risky well plan for the MC 252 well was approved by the MMS, and BP, Anadarko and Mitsui management. Similar or identical plans were undoubtedly approved and used by many operators on other wells drilled in the Gulf of Mexico. A plan that does not include enough cement to overlap the final and previous casing

strings, and that does not require running a cement-bond log to ensure the integrity of the seal is a defective plan. The fact that there have not been blowouts on previous wells does not justify the approval and use of an unsafe plan.

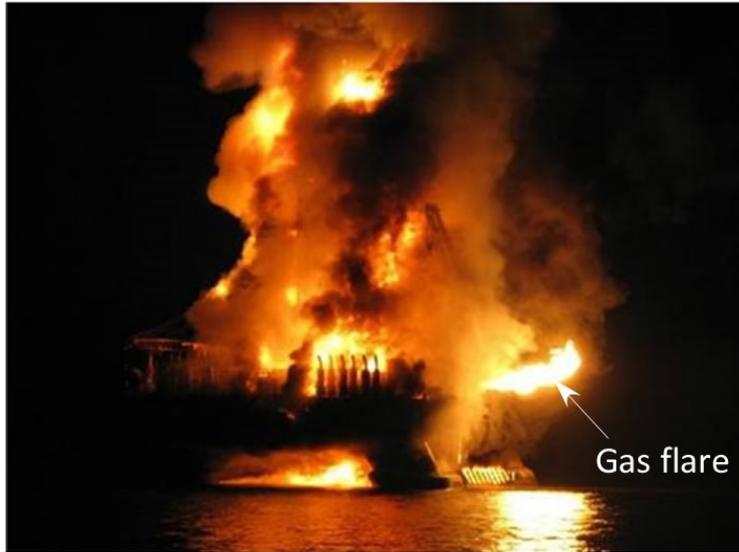
6. Sea water is much lighter than drilling mud so there was less downward force in the wellbore to balance the flow of gas from the reservoir. The drilling supervisors knew that there was gas in the drilling fluid because a gas flare can be seen in photos probably coming from a diverter line in the riser (Figure 3).

Figure3. Mississippi Canyon Block 252 Deepwater Horizon rig fire showing gas flare (http://deeperwants.com/ratboys_anvil_2/oil-rig.jpg)

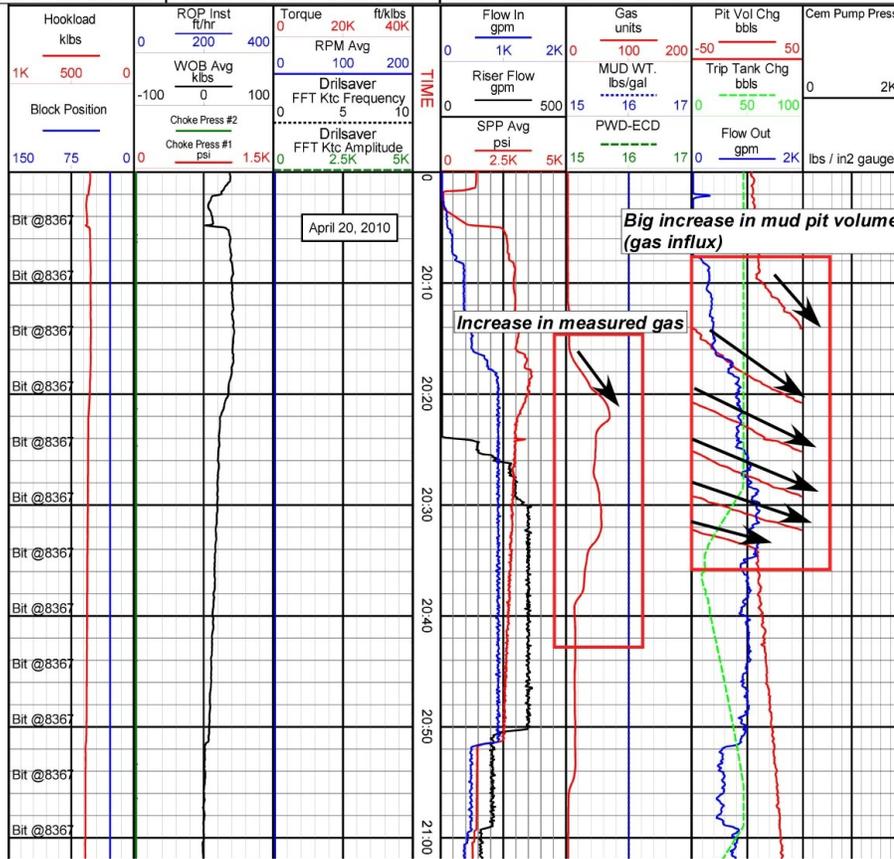
7. The chart of drilling parameters for the last two hours before the blowout suggests that the riser and upper 3,000 ft of the wellbore were fully displaced with seawater by 20:00 on April 20, and the crew was circulating the drilling fluid. Beginning 10 minutes later, at 20:10, the mud pit volume began to increase probably because of gas influx (Figure 4). The volume increased so much, that the recorder re-zeroed four times. When the crew stopped pumping at 21:08, the mud pit volume decreased and this may have alleviated some concern about gas influx.

Figure 4. Chart of drilling parameters from last two hours before the blowout of MC 252, 20:00-21:00, April 20, 2010. Modified from http://energycommerce.house.gov/Press_111/20100512/Halliburton-Last.Two.Hours.Chart.pdf

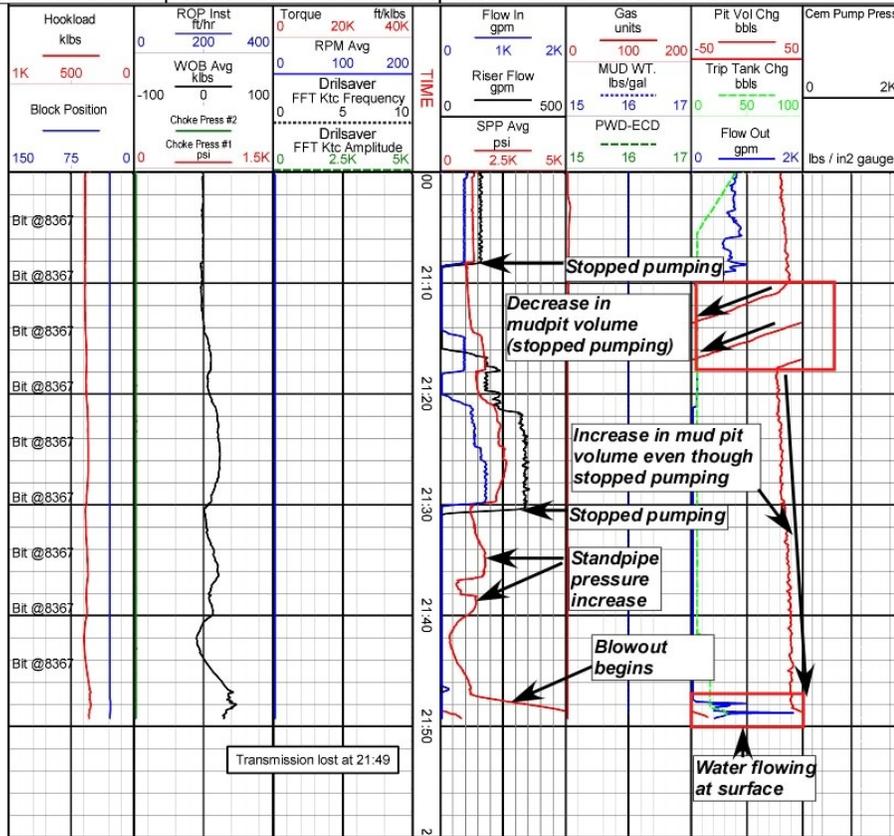
8. At 21:30, they stopped pumping again and circulated, but the pit volume continued to increase (Figure 5). Standpipe pressure increased and decreased twice between 21:30 and 21:42 (standpipe pressure generally reflects bottom hole pressure). This, along with a steady increase in mud pit volume, suggests that surges of gas were entering the drilling fluid from a gas column below the wellhead, and outside of the 7-inch production casing. Gas had probably channeled past the inadequate cement job near the bottom of the well and, by now, had reached the seals and pack-offs separating it from the riser at the sea floor.

Figure 5. Chart of drilling parameters from last two hours before the blowout of MC 252, 21:00-21:60, April 20, 2010. Modified from http://energycommerce.house.gov/Press_111/20100512/Halliburton-Last.Two.Hours.Chart.pdf

9. At 21:47, the rate of standpipe pressure and mud pit volume went off scale, and water flow was measured at the surface. The blowout had begun.
