Lessons Left Unlearned From 2003 Gulf of Mexico Near-Spill

Posted by [JoulesBurn](#) on June 4, 2010 - 7:30am

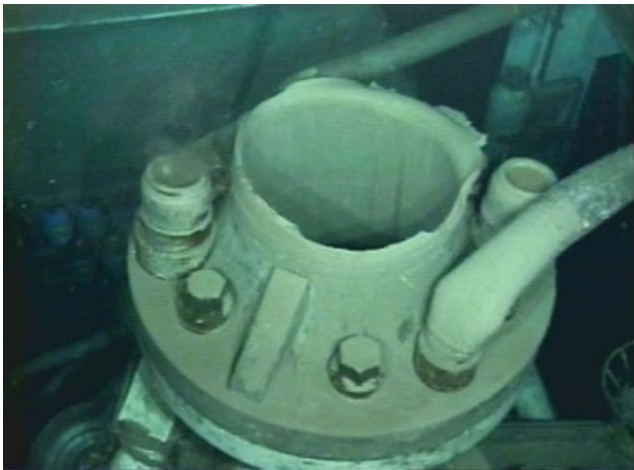
Shown below is a comparison of the Lower Marine Riser Package (LMRP) for the 2003 Thunderhorse well (with the riser "parted") with that for the 2010 BP Macondo well after the bent riser was cut off with a saw. In the case of the former, the LMRP was disconnected from the BOP using the hot stab panel. For the Macondo well, this must not have been possible, since the "Containment Cap" to collect the oil was apparently designed to be sealed around the existing LMRP.

Left: LMRP for BP Thunderhorse, 2003. **Right:** LMRP for BP Macondo, 2010

The top connector of the BOP was damaged, with one joint leaning against the BOP, dangerously close to the control lines

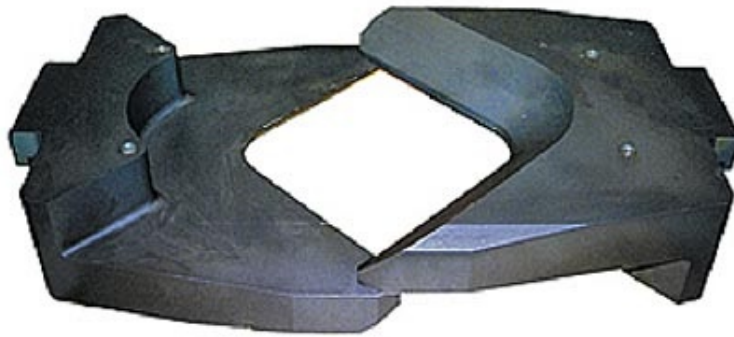
What differentiates this incident (along with many other cases of riser separation) from the 2010 Macondo spill is that the BOPs did what they are supposed to in 2003. Most importantly, the blind-shear BOP engaged, cutting through the drillstring and closing off the well.

Shear blades to cut through the DP and seal the well ([Varco](#))
