BP's Deepwater Oil Spill - Capping the Riser - Part 1 (Cap on, but leaks) - and Open Thread 2

Posted by [Heading Out](#) on June 4, 2010 - 5:01am

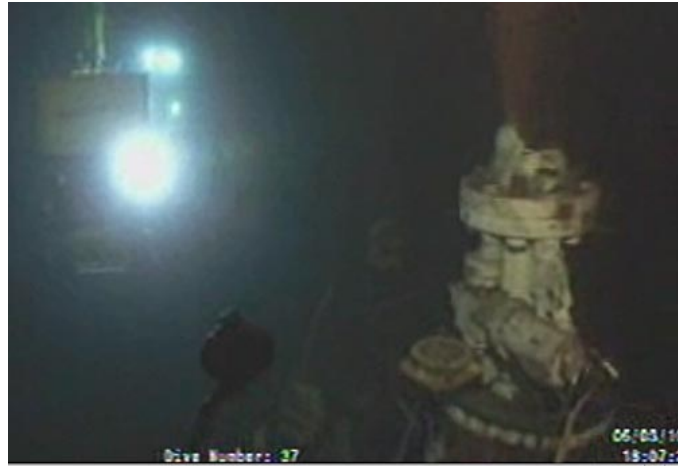
Lower Riser Assembly (LRA) atop the Blowout Preventer (BOP) at the Deepwater Horizon well, with the bent riser removed, waiting for the arrival of the Lower Marine Riser package (LMRP)

The oil and gas are rising vertically, from the top of the riser, the drill pipe (DP) and the saw cut in the side of the riser (just down from the top of the shear)

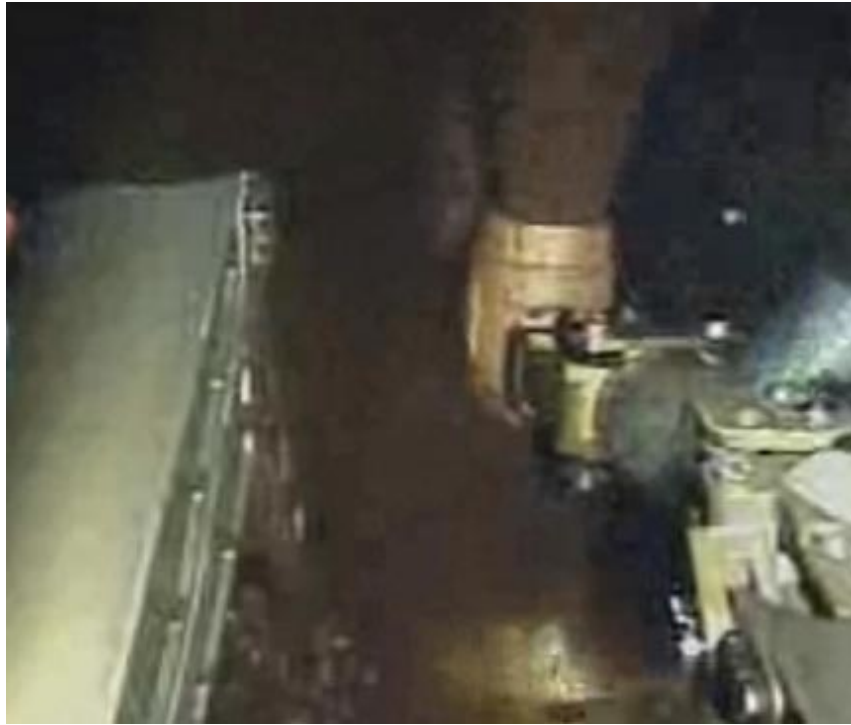
Flow through a relief port on side off the LMRP to relieve the pressure within it.

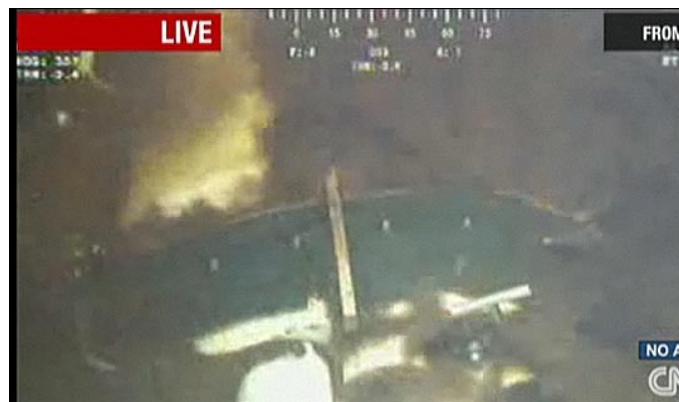
Leakage around the seal between LMRP 7 (yellow), the seal (greenish black) and the LRA. (white)

The question now arises as to whether the LMRP could be lowered sufficiently that it could seal to the flange surface, since it was no longer possible to get the seal needed on the upper surface of the riser, given that it had been distorted by the Shear which had cut the bent riser away.
