BP's Deepwater Oil Spill - Capping the Riser - Part 1 (Cap on, but leaks) - and Open Thread 3

Posted by [Heading Out](#) on June 4, 2010 - 10:24pm

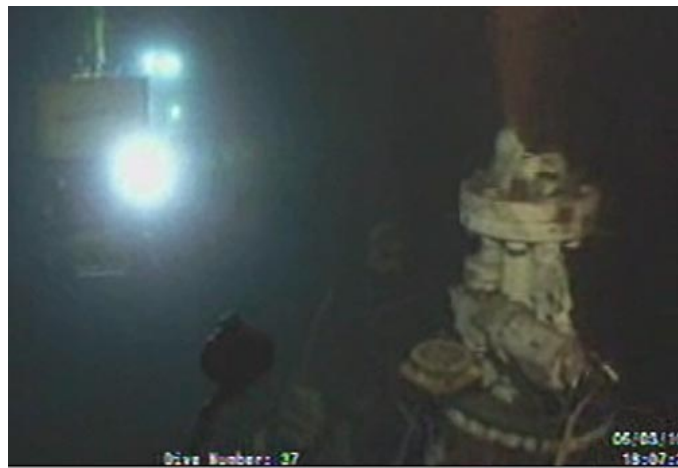
Lower Riser Assembly (LRA) atop the Blowout Preventer (BOP) at the Deepwater Horizon well, with the bent riser removed, waiting for the arrival of the Lower Marine Riser package (LMRP)

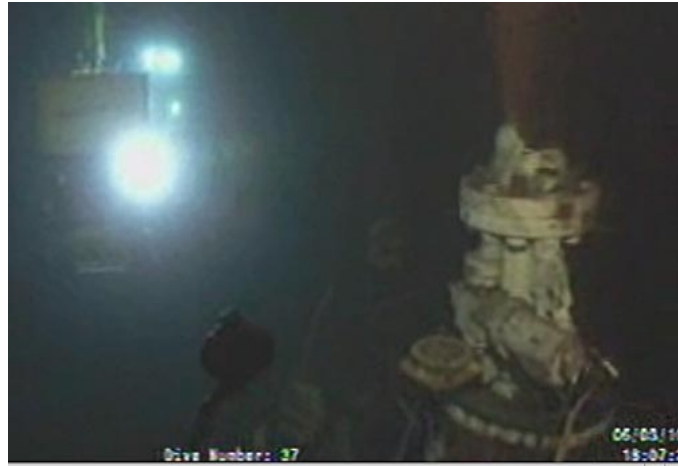
Lower Riser Assembly (LRA) atop the Blowout Preventer (BOP) at the Deepwater Horizon well, with the bent riser removed, waiting for the arrival of the Lower Marine Riser package (LMRP)

The oil and gas are rising vertically, from the top of the riser, the drill pipe (DP) and the saw cut in the side of the riser (just down from the top of the shear)

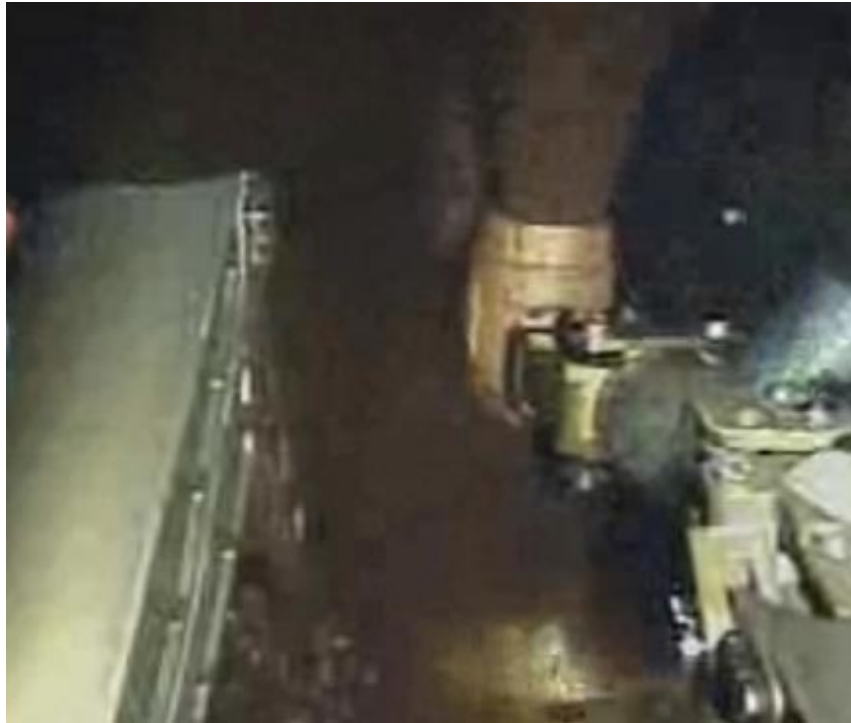
Flow through a relief port on side off the LMRP to relieve the pressure within it.

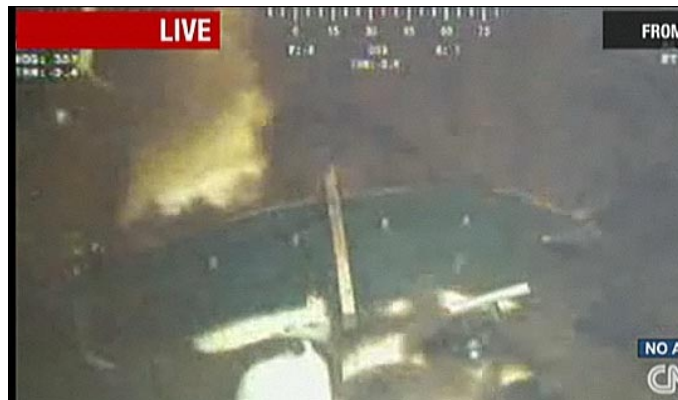
Leakage around the seal between LMRP 7 (yellow), the seal (greenish black) and the LRA. (white)

The question now arises as to whether the LMRP could be lowered sufficiently that it could seal to the flange surface, since it was no longer possible to get the seal needed on the upper surface of the riser, given that it had been distorted by the Shear which had cut the bent riser away.
