BP's Deepwater Oil Spill - Evidence of Erosion - and Open Thread

Posted by [Heading Out](#) on September 10, 2010 - 10:40am

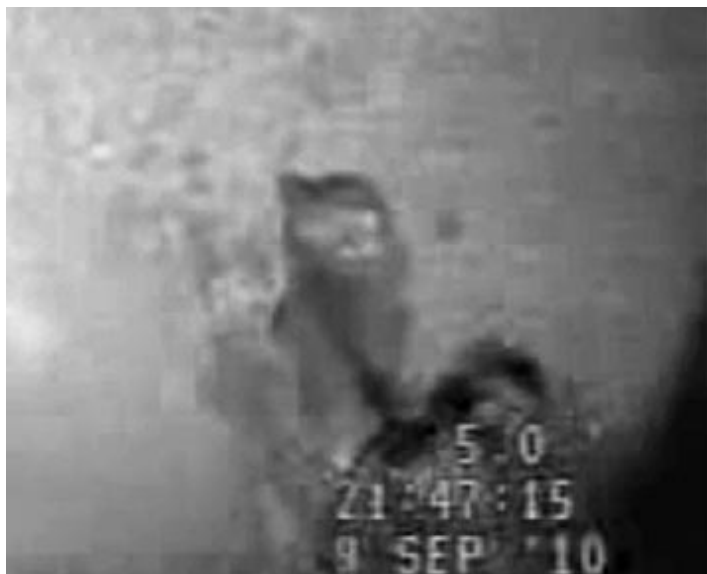
Erosion within the BOP ([RockyPaloma](#))

Some of it seems to have eaten around the plate of the shear ram, in at least one place, though I have not watched this in real time and am not sure of all the locations.

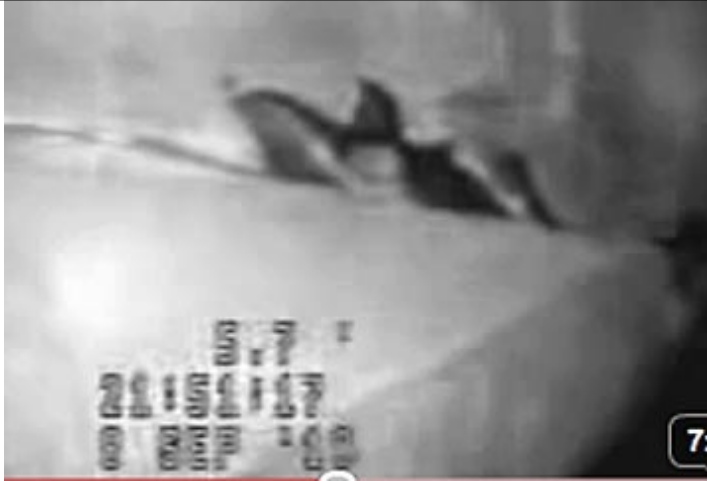
Possible erosion of the BOP wall around the shear ram plate. ([RockyPaloma](#))

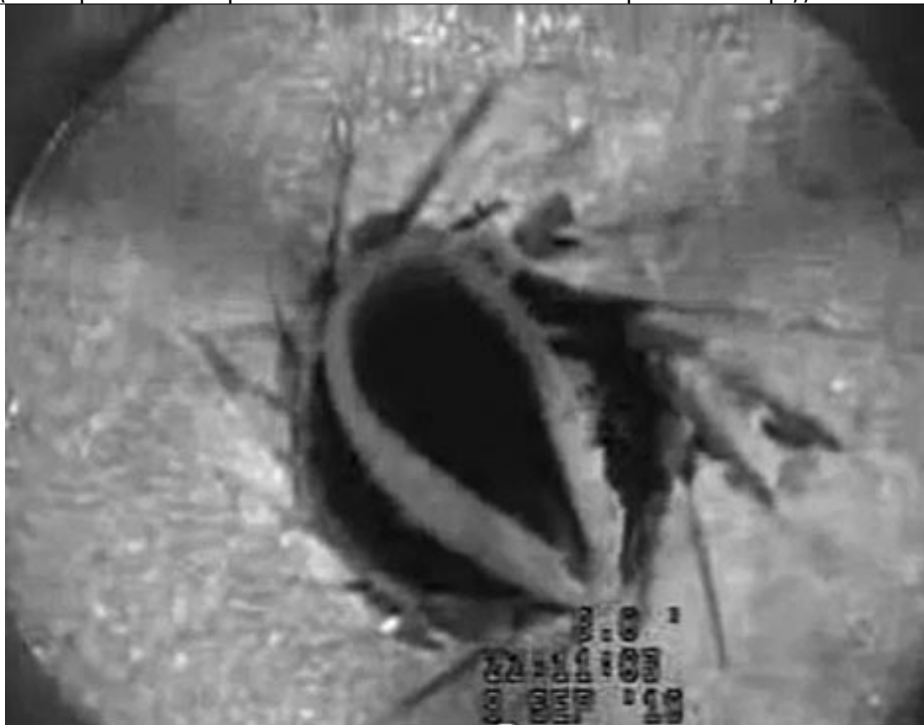
And one showing the deformed drill pipe surrounded by [the eroded annular preventer](#), gives some indication of the extent to which sand in the oil/natural gas/water mix was eating out the internal surfaces of the BOP, and allowing the leak to increase in size, over time, a point that I made, [quite early in the proceedings](#).

View of the crushed DP with surrounding erosion ([RockyPaloma](#))
