Montara Oil Spill: "A failure of sensible oilfield practice"

Posted by [Phil Hart](#) on December 8, 2010 - 11:25am

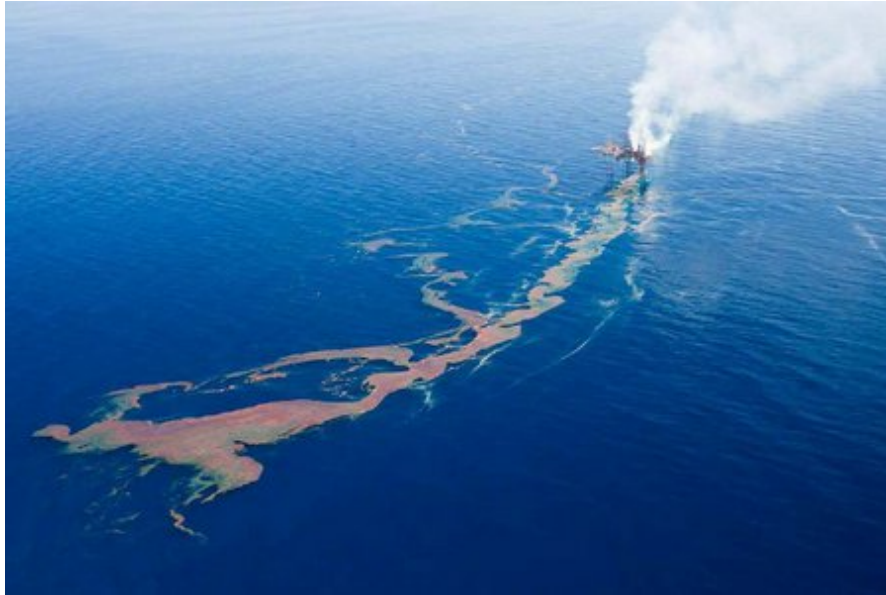
The Montara oil spill occurred after a blowout and fire on the Montara wellhead platform. The blowout occurred on the H1 well on August 21, 2009 while the West Atlas jackup drilling rig was operating over another well at the time. Sixty-nine workers were safely evacuated from the drilling rig. The leak continued for 74 days, until an intervention well was successful on its fifth attempt on 3rd November and mud was pumped in to 'kill' the well.

The Thai operator estimated that the flow of oil may have been between 1000-1500 barrels per day in the early stages and declined to 400 barrels per day later. In total it is estimated that 30,000 barrels were spilled (plus presumably a good deal of gas and/or condensate). The total surface area over which oil or sheen was observed at one time or another was around 90,000 square kilometres.

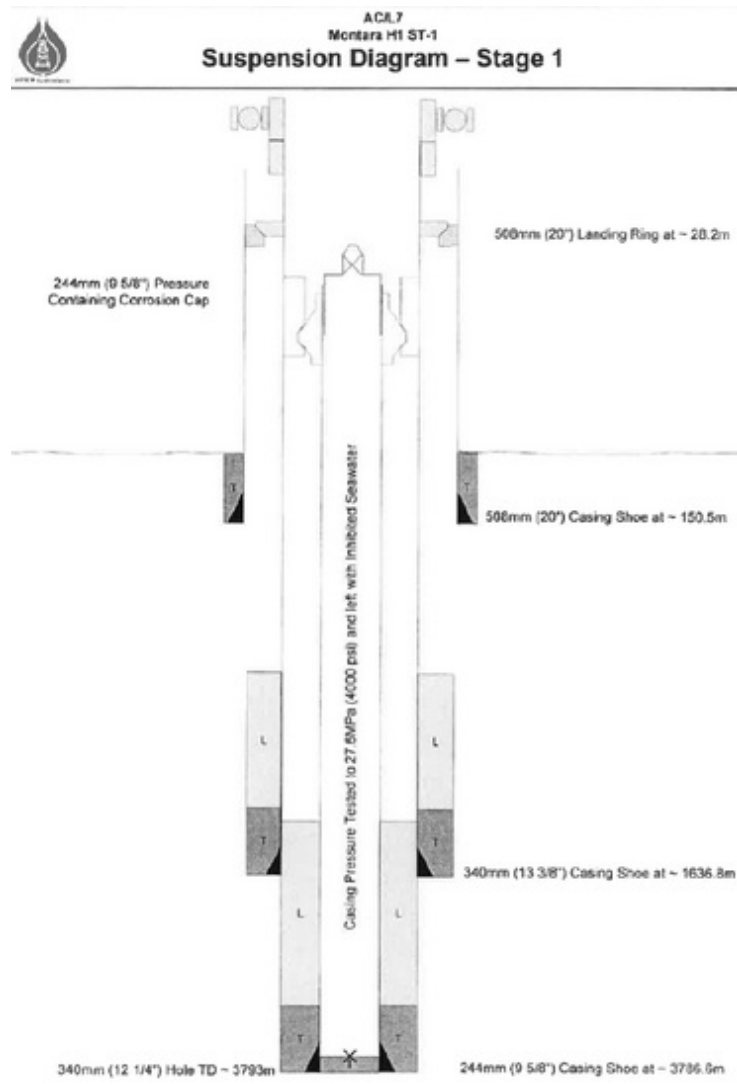
It seems that Halliburton who performed the cement job were aware there was a problem, but the operator accepted it anyway:

Despite the fact that the Halliburton cementing report clearly showed that the casing shoe could not be regarded as having barrier integrity, the report was 'signed off' by Mr Treasure (PTTEPAA's senior on-rig representative) later in the evening on 7 March 2009, with a handwritten annotation 'good job well done'.
