BP's Deepwater Oil Spill - The Saw is Stuck, Working on the Riser, and an Open Thread

Posted by [Heading Out](#) on June 2, 2010 - 7:19am

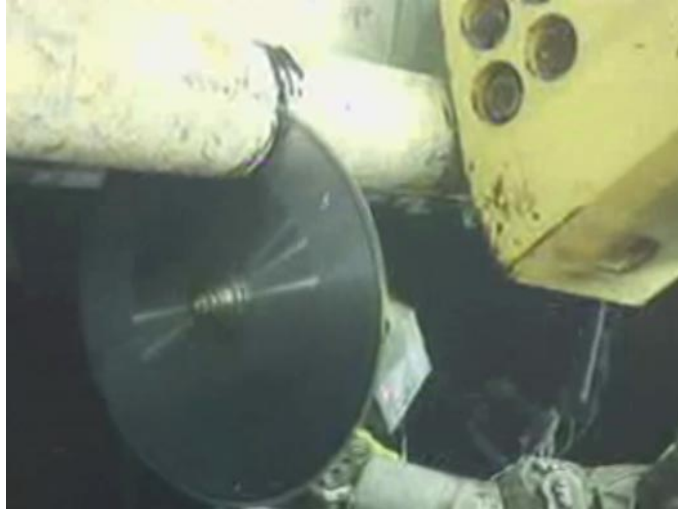
10:04 am just before the pipe was severed.

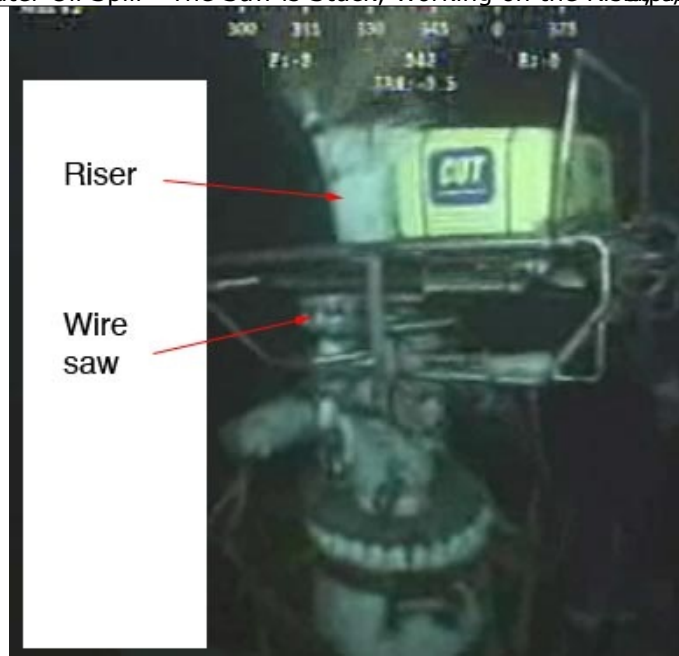
10:30 am Wire saw on riser

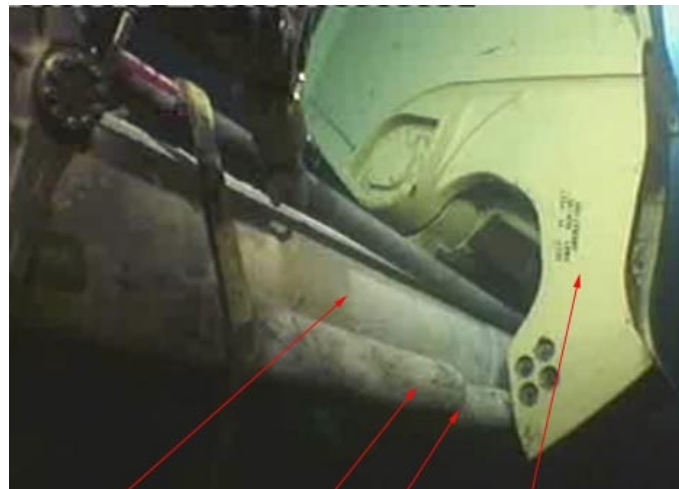
First shear location

Riser Choke line cut Shearing machine

Unfortunately the first cut did not appear successful, although there was a cloud of oil and gas released, indicating that the riser was at least breached. There was a pause, and the Shear moved to a new location closer to the riser. Again it tried to shear through the nest of pipes, that now included choke and kill lines. It was not successful, and returned to the surface where it was fixed, and returned to the site. UPDATE 1: Having written this post and not seeing much happening I went off for a couple of hours. On my return (and before Gail posted it), I did not check again and as the notes below show, the Shear worked at 7 pm. At 10:15 pm the wire saw was cutting through the riser. I apologize for the errors.

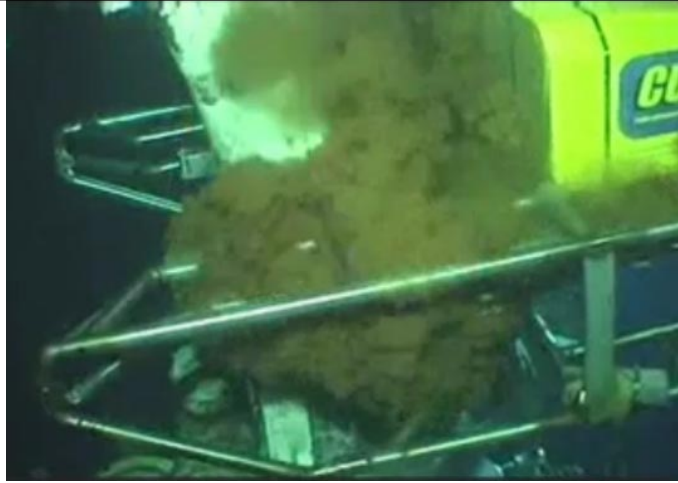
Wire sawing the riser.

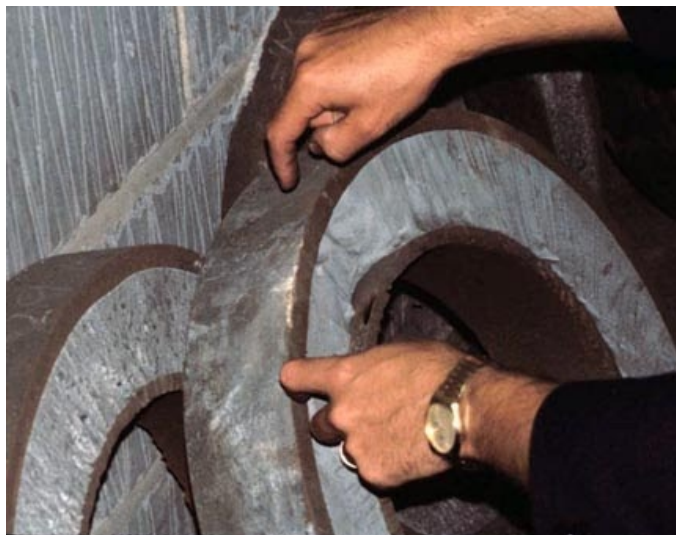
Oh, and I mentioned earlier that an ASJ system had cut through casing and pipes at the bottom of the North Sea. I had the orientation of that cut wrong (at least for the picture below) since in this case it was from the outside in, but I am aware of it being successful the other way. And so here is the picture of casing and cement cut by an ASJ. Sadly it was so long ago - around 23 years, that I can no longer remember exactly the pressure it was cut at, but I believe it was 5,000 psi.

ASJ cuts of casing from the bottom of the North Sea
