BP's Deepwater Oil Spill - The Saw is No Longer Stuck, Working on the Riser, and Wed. Open Thread 2

Posted by [Heading Out](#) on June 2, 2010 - 7:20am

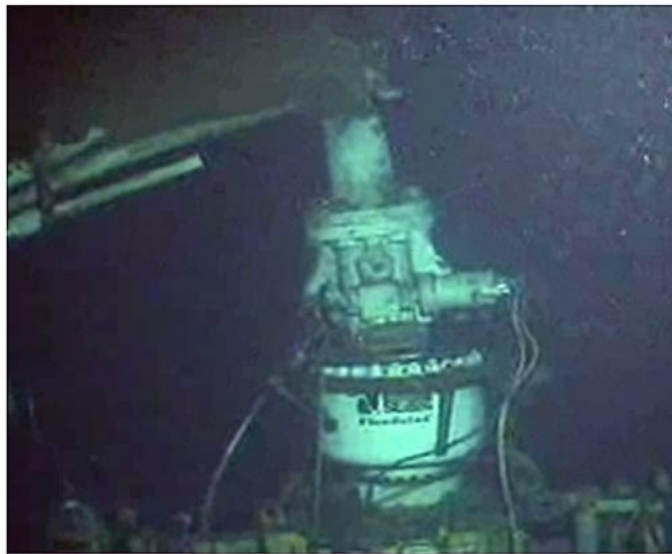
The Lower Riser Assembly attached to the top of the BOP, the riser has folded over to the left.

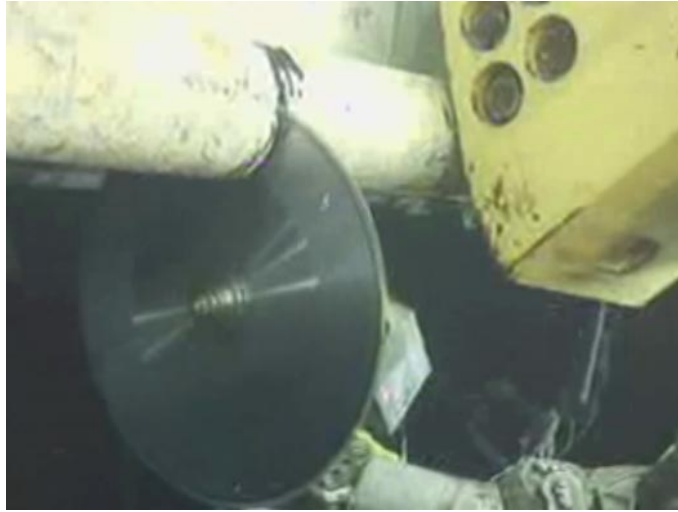
10:04 am just before the pipe was severed.

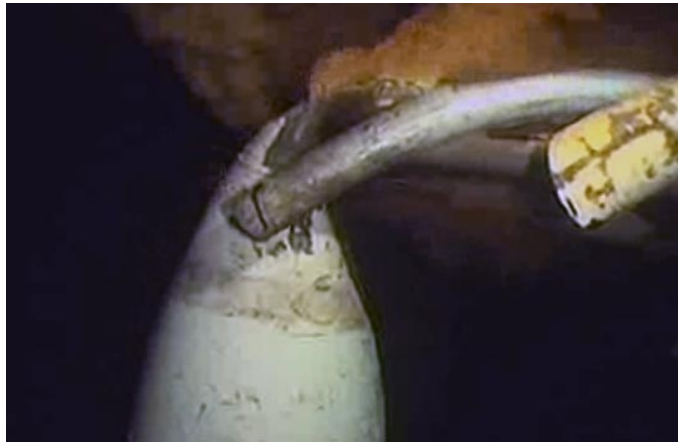
The wire saw was then located ready to make the cut.

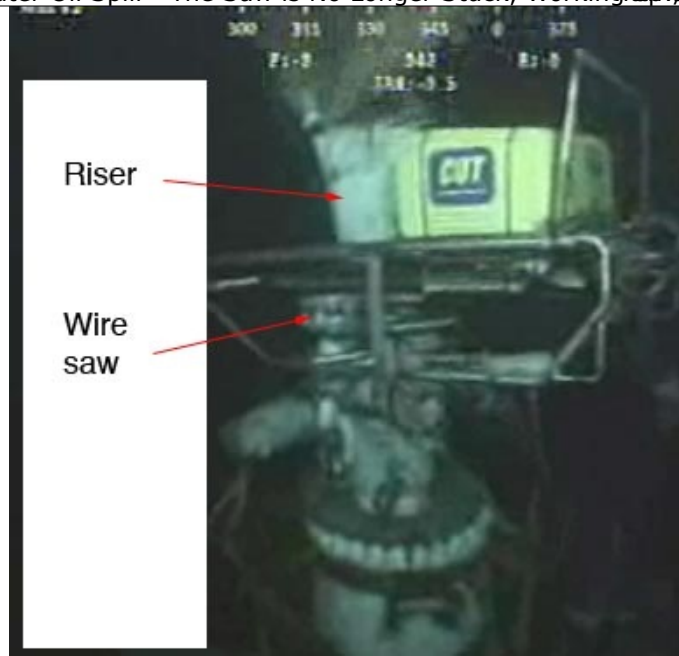
10:30 am Wire saw on riser

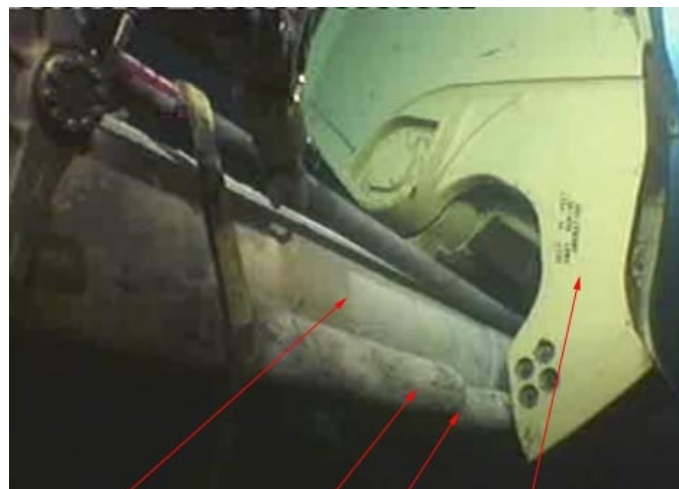
Riser Choke line cut Shearing machine
First shear location

Unfortunately the first cut did not appear successful, although there was a cloud of oil and gas released, indicating that the riser was at least breached. There was a pause, and the Shear moved to a new location closer to the riser. Again it tried to shear through the nest of pipes, that now included choke and kill lines. It was not successful, and returned to the surface where it was fixed, and returned to the site. UPDATE 1: Having written this post and not seeing much happening I went off for a couple of hours. On my return (and before Gail posted it), I did not check again and as the notes below show, the Shear worked at 7 pm. At 10:15 pm the wire saw was cutting through the riser. I apologize for the errors.

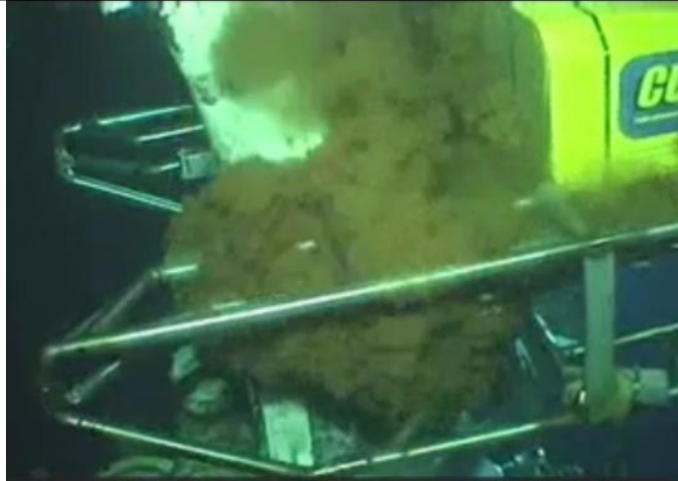
Wire sawing the riser.

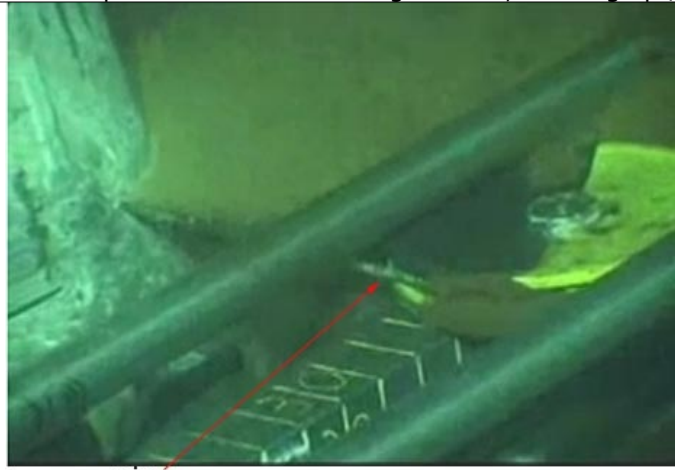
UPDATE 2: Sometime about midnight it appears that the cutting wire stopped moving and may be jammed in the cut, roughly half-way through.

Possibly jammed wire at 12:30 am

UPDATE 5: Part of the problem was [apparently according to a BP spokesman](#) that the cut through the first half had dulled the blade, so that when they got it restarted it would not cut. (What we do in those circumstances, which are not uncommon with diamond blades, is to run the blade through firebrick, and this erodes the material into which the diamonds have been pushed, and sharpen it. Then we drop the cutting pressure a little.) However, BP's current answer is going to be

The technician said that rather than trying again with the saw, the plan now was to use a large shear to cut the riser. The shear, which is about 20 feet long and nearly 10 feet high, was used to make an earlier cut in the riser about 50 feet from the wellhead. Because the shear will not make as clean a cut as the wire saw, modifications would have to be made to the containment cap that is to be lowered over the cut pipe. But the technician said that even with the switch to the shear and the modifications, he expected the containment cap could be in place by Thursday.

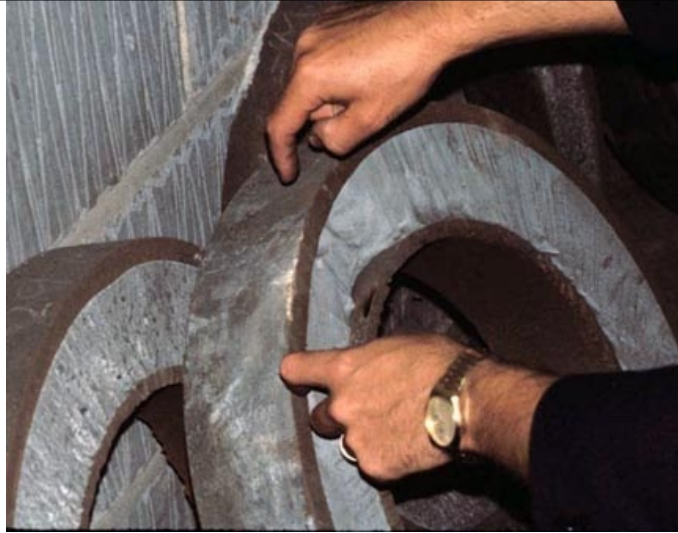
ASJ cuts of casing from the bottom of the North Sea

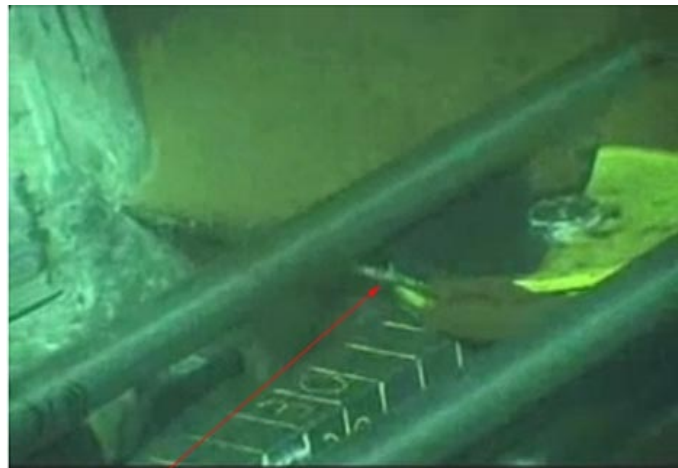
Wed. UPDATE: The wire motionless in the slot at 12:30 am

Wed. UPDATE: The wire was apparently stuck for a number of hours and they may have changed the wire, and then restarted with a second cut. BP is still predicting that the cut will be completed today and the LMRP installed.

Wed. UPDATE 2 (5 pm Wednesday): Part of the problem was apparently [according to a BP spokesman](#) that the cut through the first half had dulled the blade, so that when they got it restarted it would not cut. (What we do in those circumstances, which are not uncommon with diamond blades, is to run the blade through firebrick, and this erodes the material into which the diamonds have been pushed, and sharpens it. Then we drop the cutting pressure a little.) However, BP's current answer is going to be:

The technician said that rather than trying again with the saw, the plan now was to use a large shear to cut the riser. The shear, which is about 20 feet long and nearly 10 feet high, was used to make an earlier cut in the riser about 50 feet from the wellhead. Because the shear will not make as clean a cut as the wire saw, modifications would have to be made to the containment cap that is to be lowered over the cut pipe. But the technician said that even with the switch to the shear and the modifications, he expected
