BP's Deepwater Oil Spill - The Riser is Cut, Seating the "Containment Cap," and Thurs. Open Thread 1

Posted by [Heading Out](#) on June 3, 2010 - 7:15am

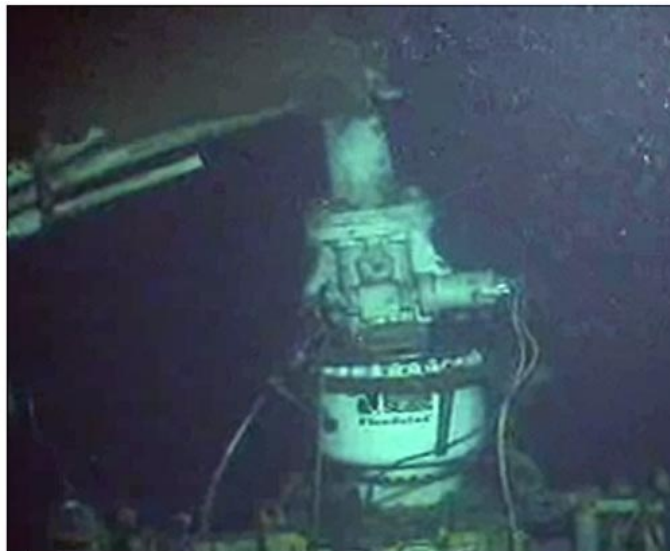
The Lower Riser Assembly attached to the top of the BOP, the riser has folded over to the left.

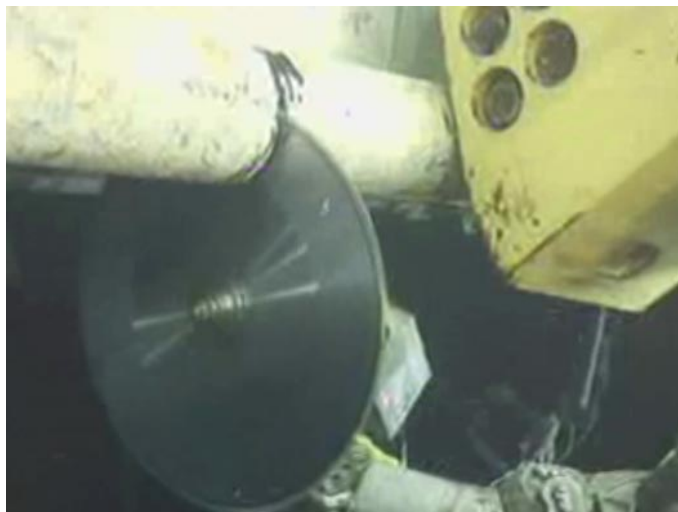
10:04 am just before the pipe was severed.

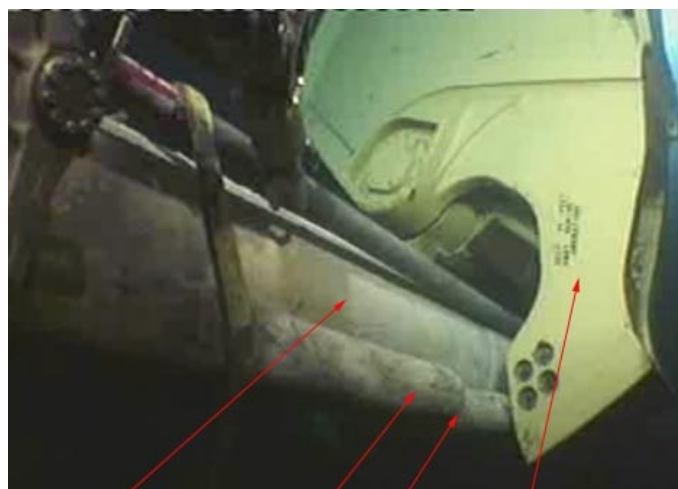
First shear location

Unfortunately the first cut did not appear successful, although there was a cloud of oil and gas released, indicating that the riser was at least breached. There was a pause, and the Shear moved to a new location closer to the riser. Again it tried to shear through the nest of pipes, that now included choke and kill lines. It was not successful, and returned to the surface where it was fixed, and returned to the site. UPDATE 1: Having written this post and not seeing much happening I went off for a couple of hours. On my return (and before Gail posted it), I did not check again and as the notes below show, the Shear worked at 7 pm. At 10:15 pm the wire saw was cutting through the riser. I apologize for the errors.

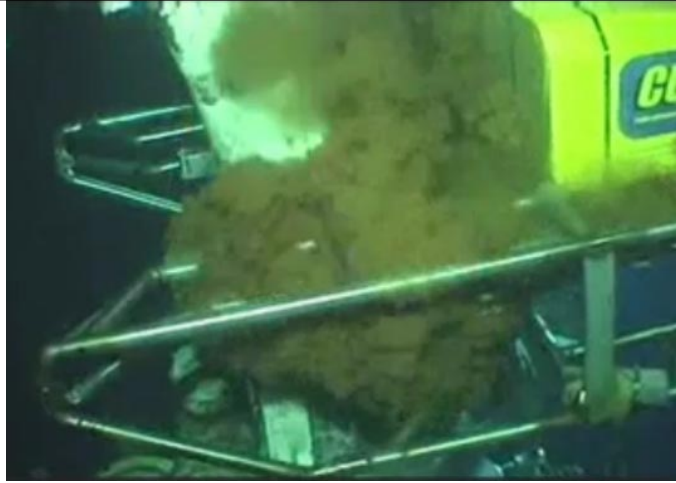
Wire sawing the riser.

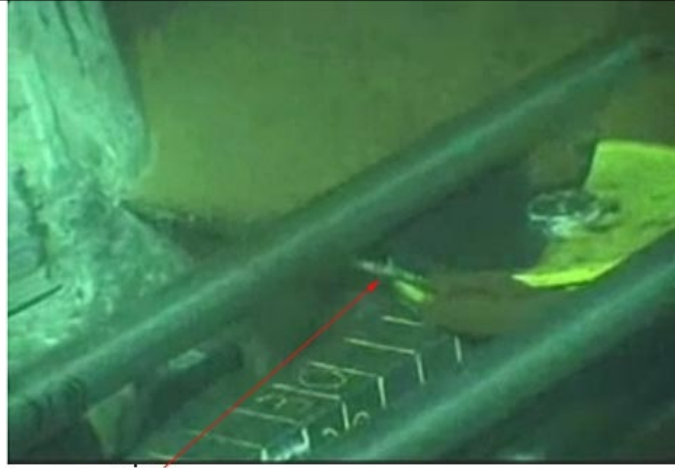
UPDATE 2: Sometime about midnight it appears that the cutting wire stopped moving and may be jammed in the cut, roughly half-way through.

Possibly jammed wire at 12:30 am

UPDATE 5: Part of the problem was [apparently according to a BP spokesman](#) that the cut through the first half had dulled the blade, so that when they got it restarted it would not cut. (What we do in those circumstances, which are not uncommon with diamond blades, is to run the blade through firebrick, and this erodes the material into which the diamonds have been pushed, and sharpen it. Then we drop the cutting pressure a little.) However, BP's current answer is going to be

The technician said that rather than trying again with the saw, the plan now was to use a large shear to cut the riser. The shear, which is about 20 feet long and nearly 10 feet high, was used to make an earlier cut in the riser about 50 feet from the wellhead. Because the shear will not make as clean a cut as the wire saw, modifications would have to be made to the containment cap that is to be lowered over the cut pipe. But the technician said that even with the switch to the shear and the modifications, he expected the containment cap could be in place by Thursday.
