## Deepwater Oil Spill - Problems with the LMRP Cap - and Open Thread

Posted by <u>Heading Out</u> on June 24, 2010 - 10:30am Topic: <u>Environment/Sustainability</u> Tags: <u>deepwater horizon</u>, <u>Imrp</u>, <u>oil spill</u> [list all tags]

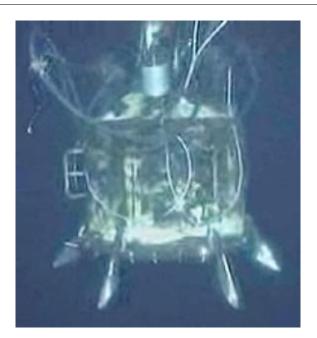
*LMRP* cap floating free 4 pm June 23, 2010 (Enterprise ROV2)

At a press briefing in Washington on the event Admiral Allen blamed the event on <u>an ROV hitting</u> <u>one of the valves</u> on the vent at the top of the cap and causing it to close. With the vent closed the pressure under the cap would increase (since the flow would have a smaller area to escape through). That increase in pressure was enough to reverse the flow through one of the lines that send warm water down to the cap to keep it warm enough that hydrates don't form.

It appears, from <u>Joel Achenbach's</u> Washington Post report that oil and gas was found coming out of a line that was pumping the water down, which raises a little question over the flow circuit being used that would allow that to happen? That discovery led to the cap being removed from the well for inspection. Any gas outlet at the surface would pose increased risk to those running the operation and had to be dealt with immediately.

The current plan is to replace the cap later this afternoon, presuming that the blockage has been removed. Unfortunately, without the pressure gage recordings from inside the cap it is not possible to know if the pressure build-up was gradual, which could be explained by this deposition of material in the flow path, or if it was a step-function which would more likely result if an ROV had nudged a valve closed.

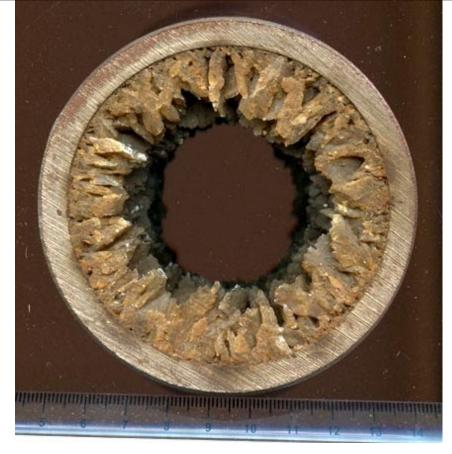
As I <u>mentioned earlier</u>, the alternate hypothesis is that there has been some crystal growth within the flow path through the cap, which caused crystals to grow, constricting the channel and thus raising the pressure in the cap itself. The pressure jump cannot have been too rapid if the indication of the problem came from the backup of oil and gas out of a water line. And crystals can form either quickly, in large size, or more slowly and insidiously.

Barium Sulfate Crystals growing in a 3-inch I.D. pipe that carried oil from the deposits under the North Sea. (Scale is in cm) (Growths of this size can occur in less than 24 hours).
