BP's Deepwater Oil Spill - Stopping the Fish - and Open Thread2

Posted by <u>Heading Out</u> on August 29, 2010 - 10:45am

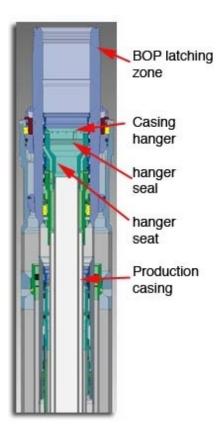
Labelled section showing the parts of the casing hanger (note that there is an animation at the <u>source site</u>)

What they're concerned about is somehow potentially dislodging the hanger and the casing hanger that is at the top of the well. That is also the – as you know that is a device that contains the seal between the annulus and the well and the blow out preventer. So the threshold for the pull has more to do with the potential to unseat the casing hanger and the seals that seal off in the annulus.

So that if you go back to the second illustration, the seal is maintained by the weight of the production casing, pulling the head of the hanger down so that the elastomeric seal spreads. If the upward lift on the BOP is transferred through the drill pipe to the top of the casing, they are concerned that if the DP is held within the casing hanger, that pulling it too hard may take the weight of the seal, so that it contracts back from the wall, and opens up the annulus.

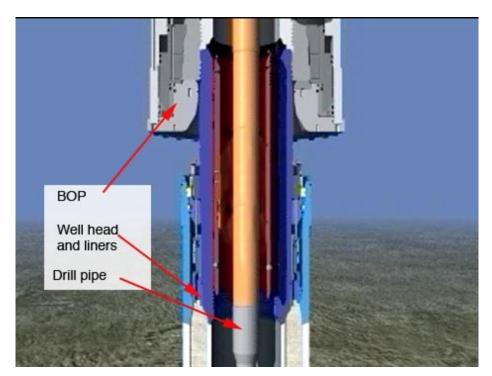
To make life easier for me I am just showing the lower end of the BOP, below the rams, the central drill pipe and the upper end of the well head (without the hanger detailed).

Now in a normal situation the drill pipe would be held by the three rams at the bottom end of the BOP, and slightly above the picture. In an ideal world there would be nothing else in the gap around the drill pipe (i.e. the annulus).

But we know that above the rams, that there is either hydrate or cement around the DP.

If the material holding the pipes extends down into the rams of the BOP and below it could fill the upper annulus down through the casing hanger. Thus pulling on the BOP would exert a pull, through the DP and this fill, on the hanger and could unseat it.

Should the BOP not move, the plan is to open the rams on the BOP, so that it no longer holds the pipe. But if the rams are cemented in place by the fill, this may be very difficult to do, since trying to flush out that fill on Thursday evening didn't work. And even if it did work, the fill may occupy the annulus between the BOP and the DP below the rams and above the latch, so that the DP is still held by the cement. (At which point if the chemicals don't release it they might try the jetting again, since that works both on cement and hydrate.) It is only by freeing the BOP from the drill pipe, and hoping that the pipe remains held by the underlying fill within the hanger, that the BOP can be released, removed and replaced.

The problem is that if, when the rams are opened, the cement/hydrate holding it is not strong enough, then the pipe may fall to the bottom of the well, carrying with it the evidence on what actually happened to it within the BOP. (Opening the rams will also drop out the other two pieces of pipe currently above the rams). Tough decisions.
