The Chilean Miners - Nearing a Rescue

Posted by Heading Out on October 11, 2010 - 7:02pm

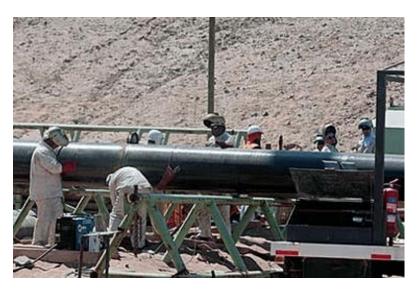
Preparing the casing for the shaft

The rate of progress in rescuing the miners from the copper mine in Chile continues to be better than expected. After the completion of the rescue shaft on Saturday, it was inspected, and the top 300 ft was considered to be possibly unstable and so has had to be lined with a metal casing. This is somewhat similar to that used in oilwells, except that it does not have to be water-tight and can be hung from the top, through a lip that extends outwards, again without need for a seal. This liner was inserted in 20 segments, and is only needed for the first 300-ft since a survey of the rest of the 2,300 ft long shaft has shown that the rock around it is solid, and does not need support.

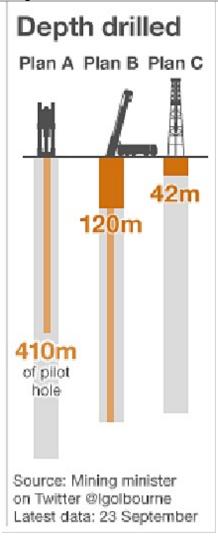
There were three different drills used to try and create the rescue shaft. The first of these, a Strata 950 was brought to the site on August 22nd, and drilled its own access bore, which would then be subsequently reamed to the necessary diameter for the rescue capsules. As a back-up a second drill, a Schramm T-130 was brought to the site at the beginning of September (the fourth). In contrast with the first drill, which was drilling its own access borehole, this unit was set up to ream one of the existing boreholes (of which there were 3). By doing this, and reaming the hole in two stages, rather than just one, progress could be considerably faster. The initial diameter of the hole was 6 inches, this was first reamed out to 12-inches, and then to the final 26-inches. After set-up the benefit of the two-stage operation became evident early on, with the T-130 being able to ream the initial bore out to 12-inches by the 17th of September. Fifty days after the collapse of the mine tunnel, progress for what was now three different operations, was shown in this graphic.

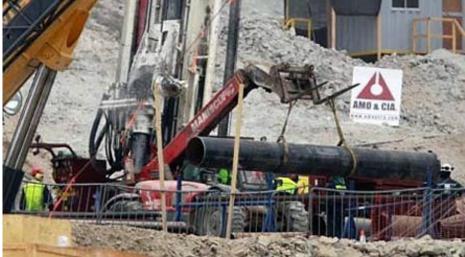
Moving the liner into place

One of the concerns with the existing shaft is that, as a result of the way that the hole was drilled, it is not straight but has a number of curves in it. These are not severe, but could possibly cause a problem with the cage. By this morning the lining had been completed, and the infrastructure is being assembled over the shaft to be able to wind the cage in and out of the mine.
