BP's Deepwater Oil Spill - The Saw is Stuck, Working on the Riser, and an Open Thread

Posted by [Heading Out](#) on June 2, 2010 - 7:19am

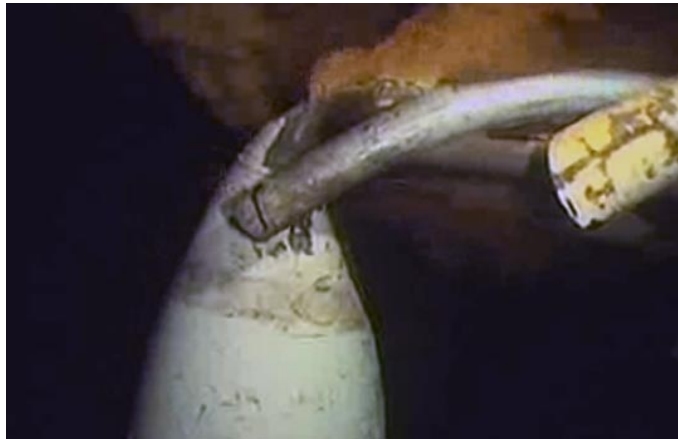
At the same time that this was going on, the wire saw that would make the final cut on the riser had been brought down to the site. The riser assembly has been cleaned of extraneous pipes already, and the wire saw would fit about the flange and below the bend.

The wire saw was then located ready to make the cut.
