BP's Deepwater Oil Spill - Capping the Riser - Part 1 (Cap on, but leaks) - and Open Thread 3

Posted by [Heading Out](#) on June 4, 2010 - 10:24pm

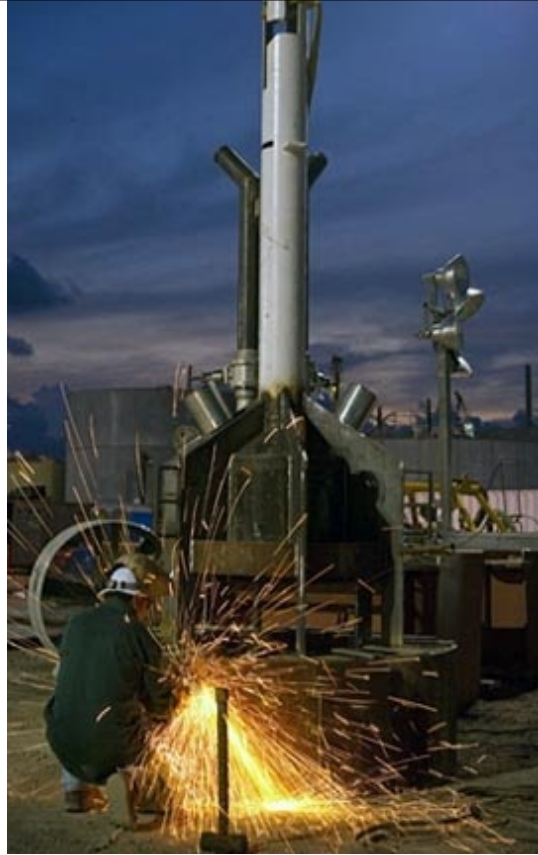
Building LMRP 7 on June 2nd at Port Fourchon ([BP](#))

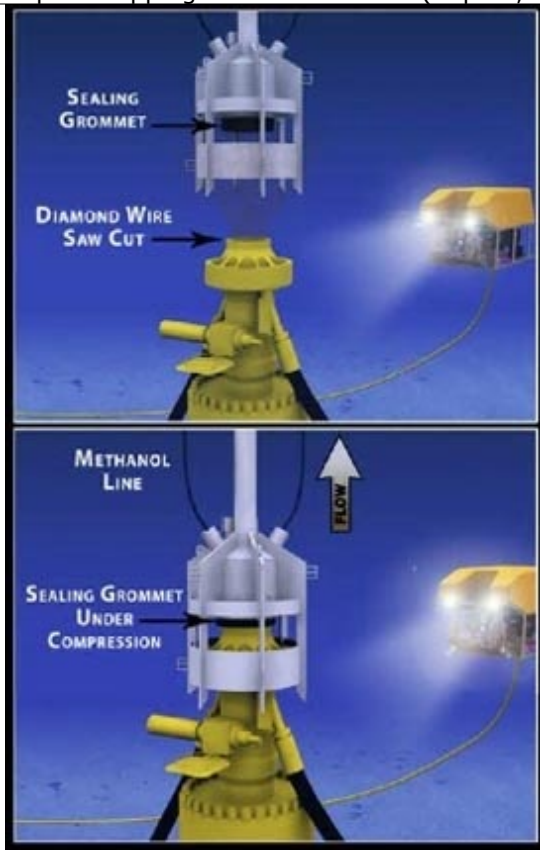
The [*Lower Marine Riser Package \(LMRP\)*](#) option

For those who may not remember, this was the initial plan as it was proposed.

So far it is not quite as simple as the sketch would suggest. But I will put this up, and then update, as changes appear.
