Offshore Wind taking off - some background on installation issues

Posted by [Jerome a Paris](#) on February 3, 2010 - 10:53am in [The Oil Drum: Europe](#)
Topic: [Alternative energy](#)
Tags: [offshore wind](#) [[list all tags](#)]

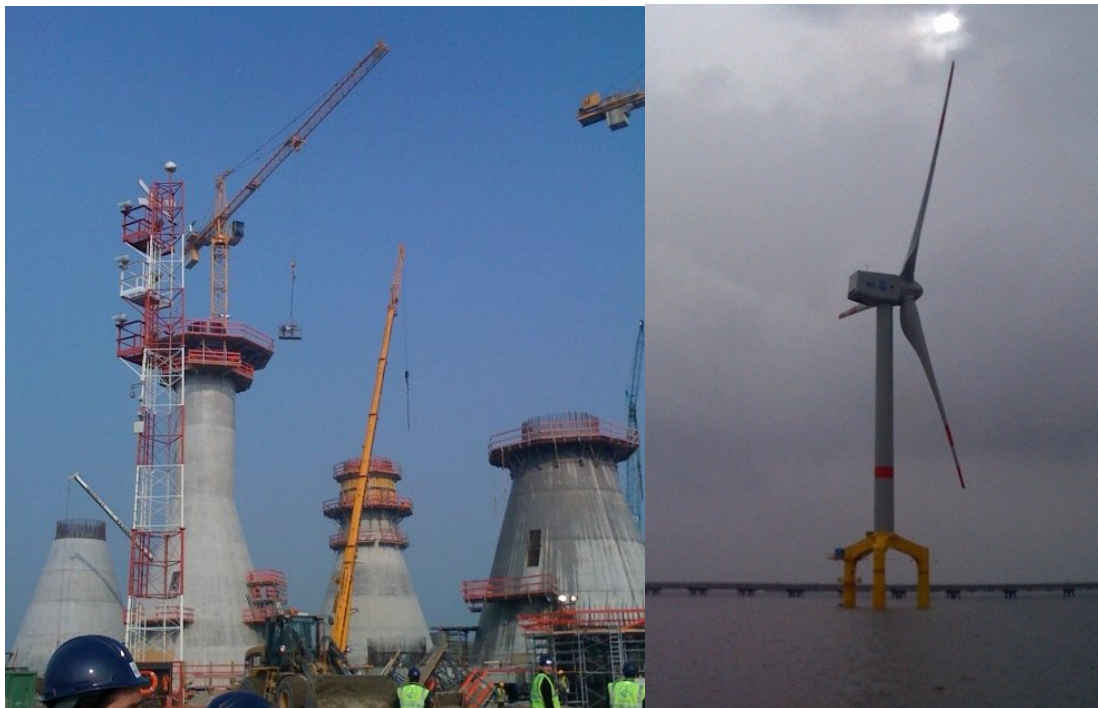
Here are gravity-based foundations and tripods (you can see more pictures here: [The unexpected weight of hope](#))

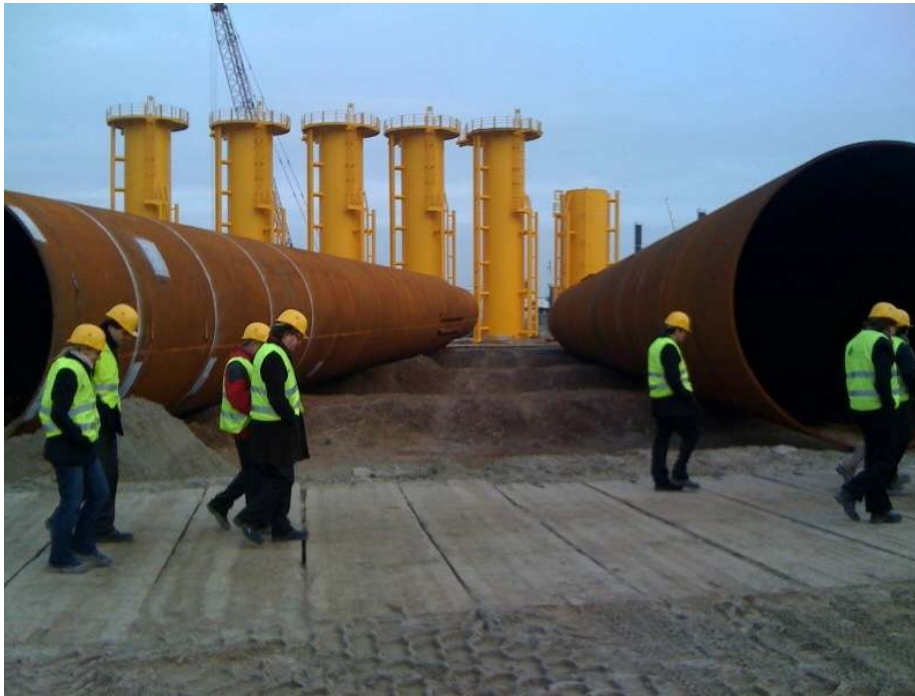
Foundations include two main parts, the foundation itself (the part that's driven into the subsoil) and the transition piece (the part that's affixed on top of the foundation and carries the turbine tower).

*two foundations on the ground
with several transition pieces in the background*

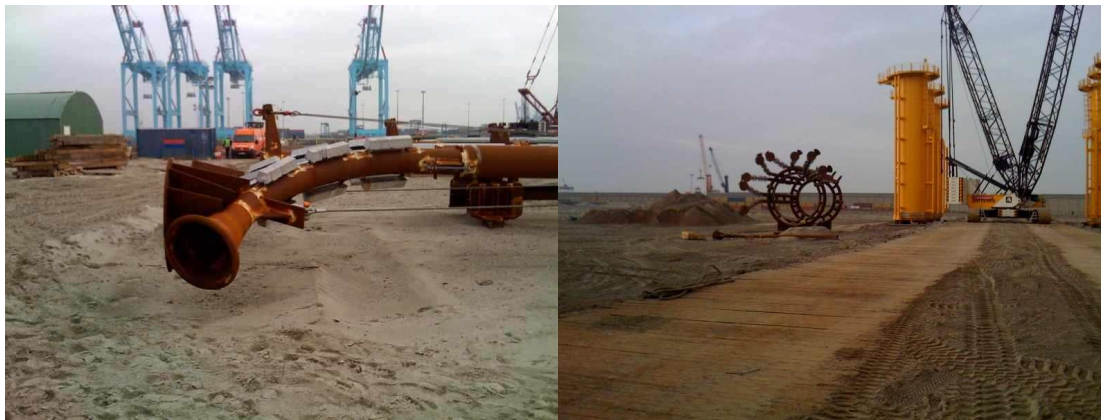
The transition piece usually includes the boat landing, access platform and j-tubes (the steel tube that protects the electrical cable going to other turbines and/or the transformer station, it is curved near the ground to allow the cable to go from its underground trench to the turbine, thus its name).

*On the left, you can see the bottom part of the j-tube,
while the right picture has the more complex set of j-tubes for the transformer station,
which has several cables going to several "strings" of turbines.
Note the anti-corrosion protection on the j-tubes.*

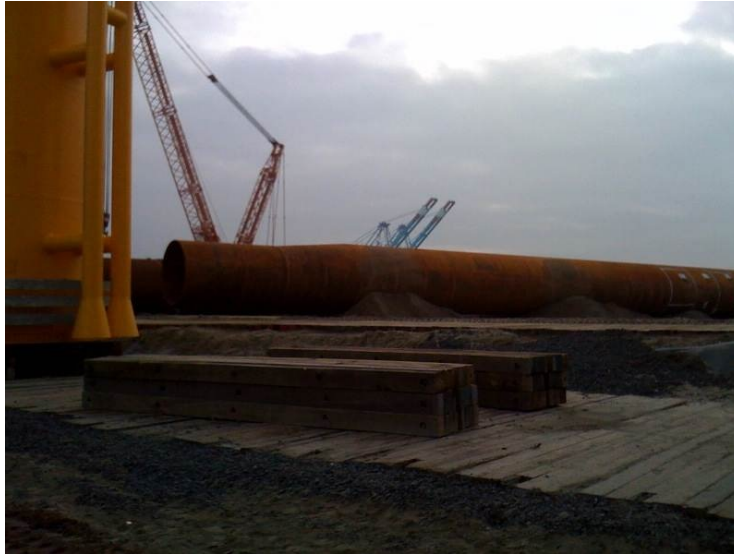
The foundations here have a smaller diameter in their top part, in order for the transition piece to be lowered on top of them and around them. The two parts are then grouted together (a special concrete is injected between the two pieces, this is done on site, naturally, and under water).

*the narrower top part of the foundation is quite visible on this picture.
Note the steel tubes alongside the transition piece in the foreground;
the j-tubes will be attached to these alongside the foundation part under water.*

Some offshore windfarms use a different connection between foundation and transition piece, with the transition piece snuggling inside the foundation. One European windfarm has quality issues on the grouting in that configuration, and there are worries that the turbines could slip lower into the foundations (which is not that important) and lose their horizontality (which is a big problem...). with the design here this is less of an issue as the wider diameter below acts as a stop should the grouting fail.

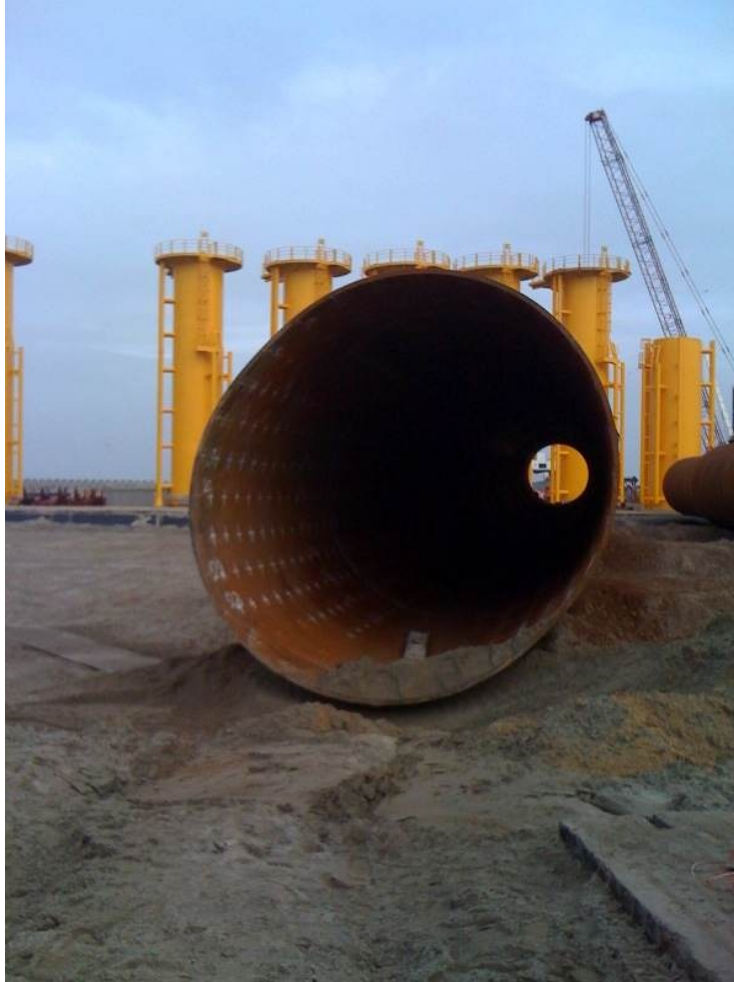
oops - ovality

"Ovality" is also an issue for foundations as the transition pieces need to fit on top of them, and it needs to be checked carefully.

As you can see, the above foundation has a serious problem: it's really not round. In that case, it is not a manufacturing problem: that foundation sank during the transport to site and hit the seabed... The project company, together with the insurance companies, is investigating the best way to deal with this problem: replace it completely, try to improve its roundness by squeezing it back into shape (the giant steel "pinch" for that was being prepared on site when we visited) or, quite possibly, use it as it is (by luck, it is the bottom part which was damaged, ie the part that goes in the sand, so ovality is less of an issue there as long as the vertical penetration in the soil can still be controlled).

The reason the foundation sank is that it was transported to site by floating it - plugs were installed on each end and the foundation could simply be pulled on the water.

But the design of a plug was found (after a number of trips) to be slightly faulty and water seeped in, leading to the incident. The foundation was recovered, and the design flaw was identified and has now been corrected. Transport of the foundations to the site was of course interrupted during the investigation, but by luck the weather was poor at that time so no work could have been done in that period... The pictures above show the new improved plug system, which includes a more comprehensive set of sensors to warn of any risk of infiltrations...

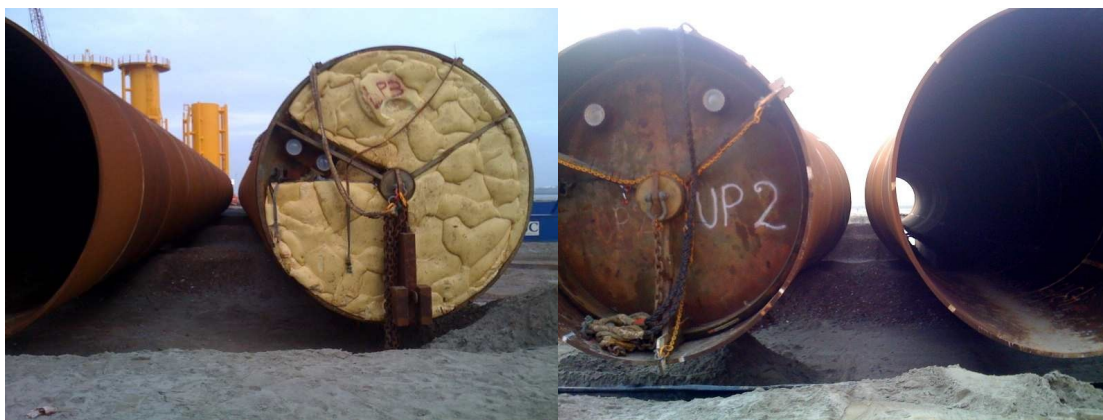
the two plugs used to float a foundation,

*One of these is filled with foam, as it needs to be taken off underwater,
when the foundation has been raised vertically,
and the foam makes it float back to the surface to be recovered.*

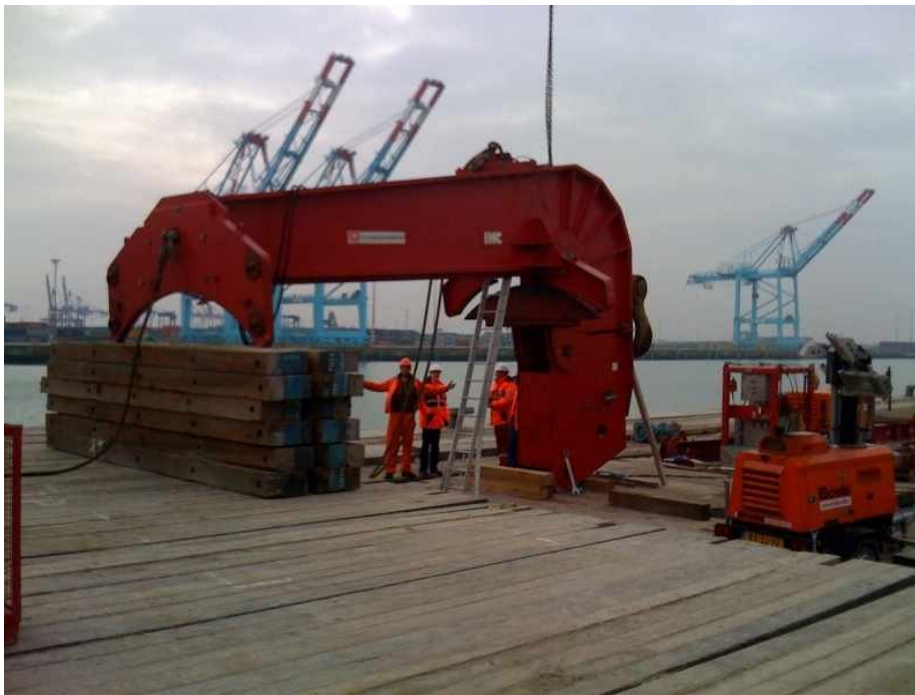
*this is the special piece of equipment used to "grab" foundations
and bring them from their horizontal transport position to the vertical on site.
It was temporarily on site for some repairs/maintenance.*
