The Gulf Deepwater Oil Spill - the Top Kill Attempt

Posted by [Heading Out](#) on May 25, 2010 - 7:30am

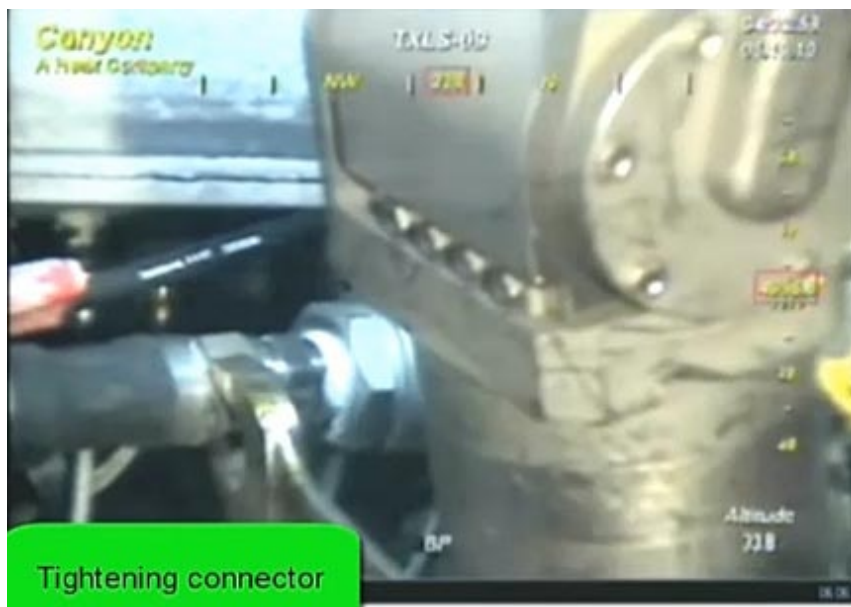
ROV image showing the control pod fitting being tightened

The tasks to be done included removing, modifying and replacing the control box (or pod) that operates the valves that open and close the flow lines into the choke and kill lines on the well. Other than this, the flow lines to the flow and choke lines themselves had to be replaced with the feed lines (shown in the animation) that will carry the mud into the well. Even tightening a fitting that had worked loose takes time, when it has to be done using an ROV (with the operator at the surface needing to see what he is doing while getting the ROV to hold the necessary wrench and turn the fitting). The old feed lines then had to be cut from the BOP, and replaced.

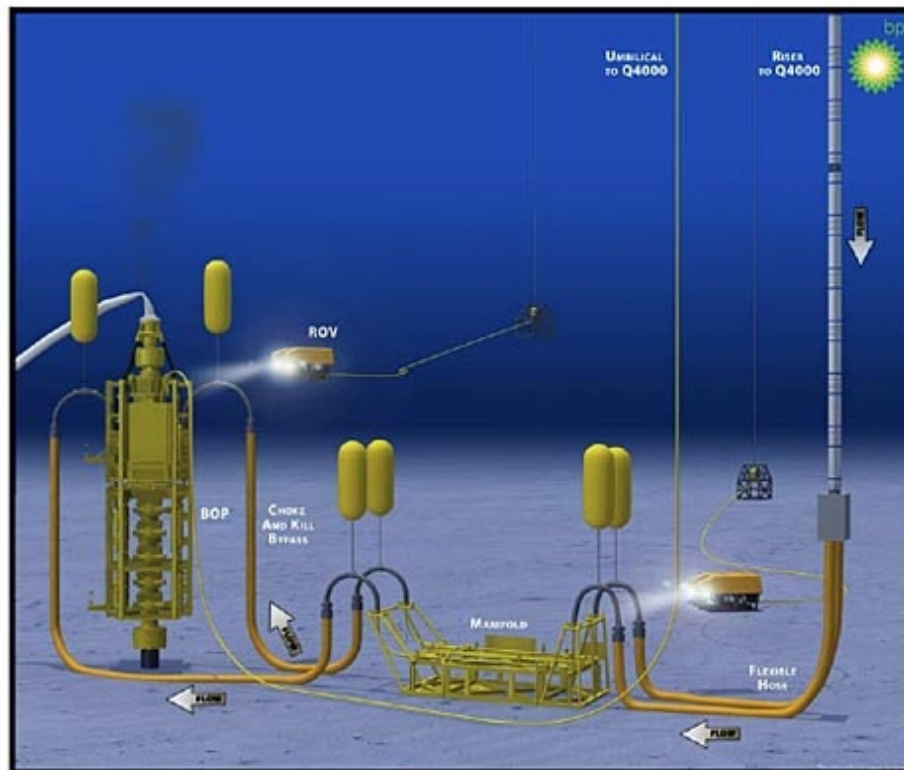
[Top Kill Circuit](#)

The process will be controlled from the [Q4000](#), which is designed to have the capabilities needed. Two lines feed from the vessel to the BOP. The first carries the control feeds through an umbilical, while the second is a riser that carries the mud down to the flexible hoses and jumper lines into the BOP itself. This mud, at about twice the density of water, will be delivered from the two high-pressure Schlumberger [MD 1000 mud pumps](#) made by Schlumberger and will flow through the two feed lines that were the choke and kill circuits, into the well itself, below the main Rams of the BOP.

The pumps will deliver the mud into the lines at a pressure of 6,800 psi, but as Kinuachdrach has correctly noted, it will then acquire the pressure from the full 5,000 ft column of mud as it flows

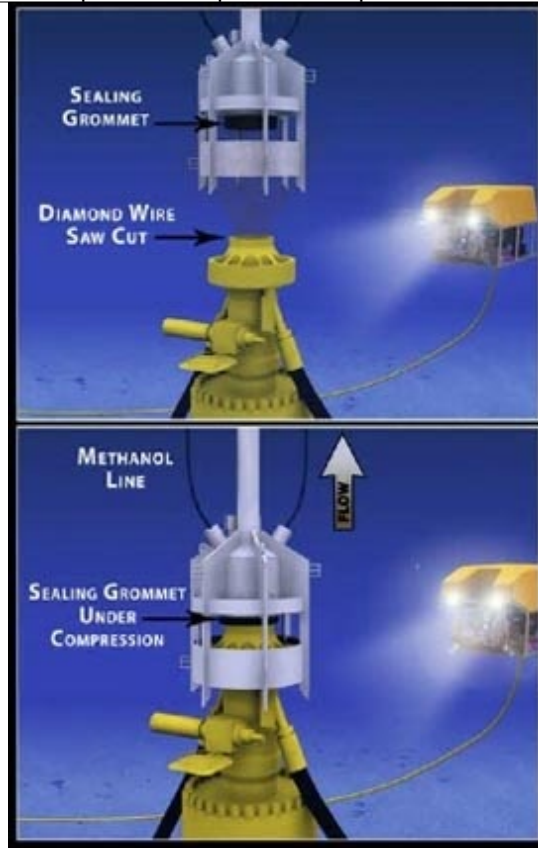
The [Lower Marine Riser Package \(LMRP\)](#) option

If the top kill fails, then the next step will be to cut off the riser, and use the top hat that is sitting on the sea bed near the well, to capture the flow in the LMRP option.
