BP's Deepwater Oil Spill - Relief Well Intersection Version 2 - and Open Thread 2

Posted by [Heading Out](#) on August 12, 2010 - 10:35am

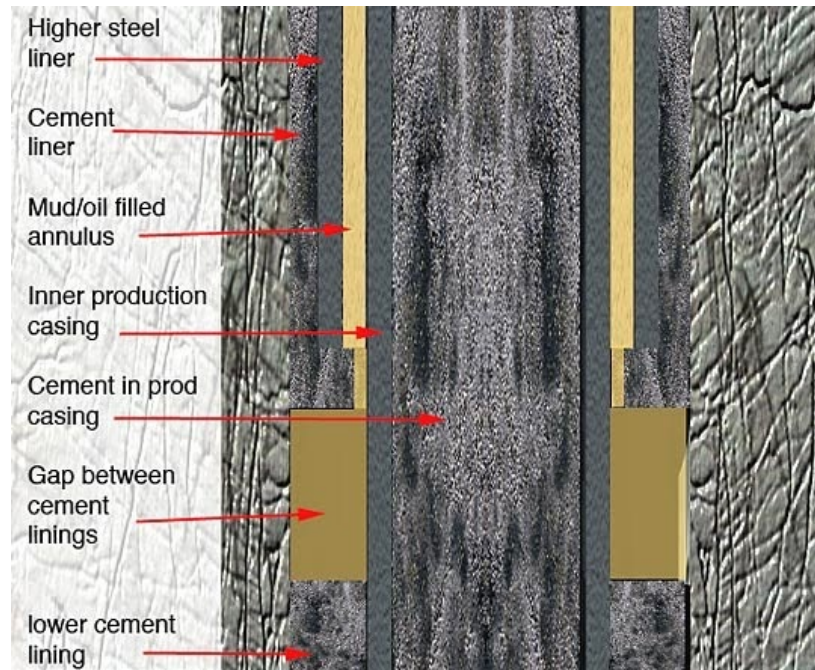
So that if I go back to the original situation at the intended intersection point, what it may well look like at the moment is this:

The vertical gap between the two outer cement linings which (for simplicity) I have shown as very short is actually likely to be a couple of hundred feet long perhaps. The inner cement plug within the production casing stretches several thousand feet above the intersection point.

The bottom of the well is some 800 feet further down the production casing. At the present time the well is being held at 4,200 psi pressure at the BOP to check and see if there are any leaks. Just as an observation when you put that much pressure on that long a solid confined column it will dissipate out to side loading long before it gets down to this depth, so the test does not have that much value in these particular circumstances. As far as testing the integrity of the central cement plug, neither will the negative pressure test which they intend to follow the current positive pressure test with. In this case they will lower the pressure in the well to 2,300 to 3,000 psi, and see if the well makes fluid. Again, because of the length of the cement column in the production casing, that drop in pressure will not extend down to the intersection point (let alone the bottom of the well) and thus won't provide that much information on the conditions at the reservoir.

What it will do, however, is provide some information about what might be going on in the annulus and particularly what might be in the gap, and the condition of it before the relief well runs into it. If the integrity of the production casing remains, (except potentially at the bottom of the well) and all the mud and cement flowed down it, and into the formation, then there may be no way for the fluids in this annulus to have escaped the well. (I have colored them an off yellow since we don't know if they are oil or mud.) If they are the original drilling mud, and the lower cement lining around the production casing has retained enough integrity to seal this zone off from the bottom of the well and the reservoir, then this may even still be the mud used just prior to the cementing of the production casing.
