BP's Deepwater Oil Spill - Hydrates and San Jose Mine Concerns - and Open Thread

Posted by [Heading Out](#) on August 27, 2010 - 10:30am

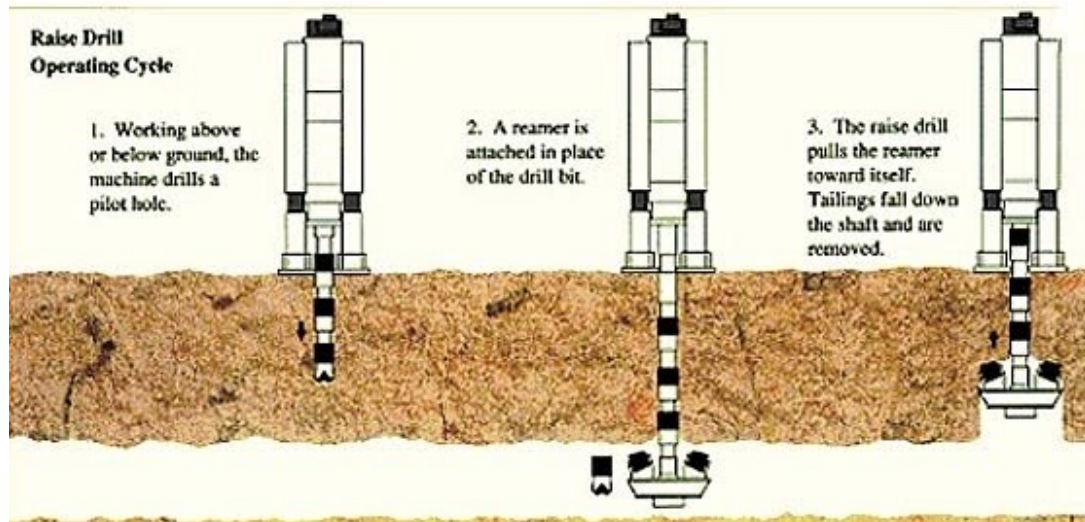
Raise borers normally work by drilling a small hole (13-inch diameter) down from the surface to

an existing underground space. Then a reaming head is attached to the drill steel at the bottom of the hole, and the head rotated and pulled back up the hole, allowing the debris to fall into the larger hole below it. It is a relatively fast and effective method of creating shafts, and is increasingly used at the surface and in underground mining.

Normal use of [a raise borer](#).

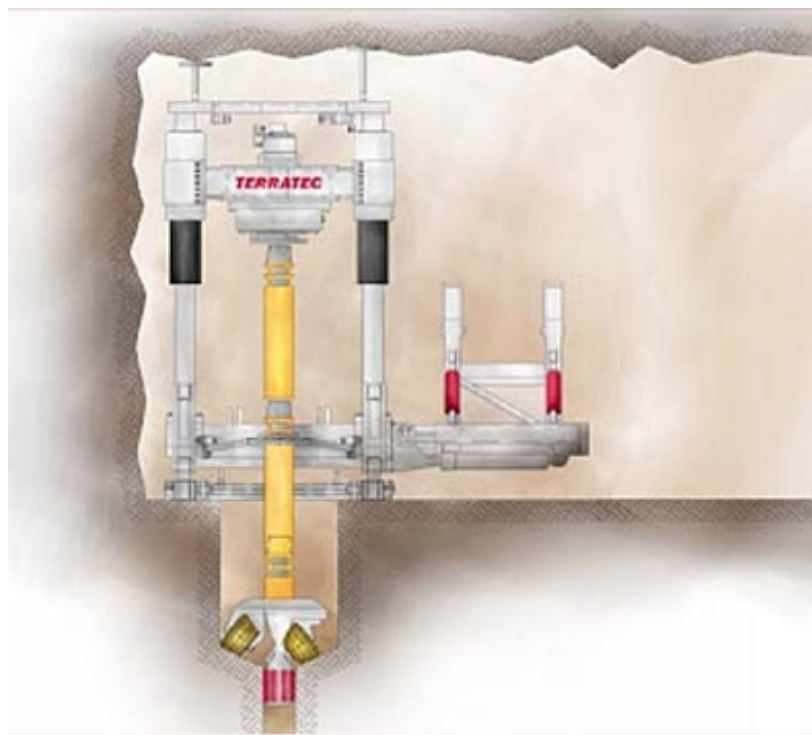
This alternate way of drilling is not as fast, since the operation has to be careful not to block the borehole with the cuttings from the reamer, and it is a little more difficult to keep going straight. The following two pictures are of [a competing model](#) but serve to illustrate the principle of the Down Reaming process:

In contrast to up-reaming, the drill shaft is in compression which might help on longer bores. One of the drilling requirements is to watch the torque that develops in the drill rods, since this can build-up to sufficient levels that, if suddenly released (as in drilling broken rock), it can whip the head around sufficiently fast as to break the string.

In some cases, such as the present one in Chile, it is not possible to get the larger reaming head down to the bottom of the shaft. In that case, once the initial central bore has been completed, then a second reaming head is mounted and will drill down along the same line, with the debris still falling down the central hole, and being disposed of underground.

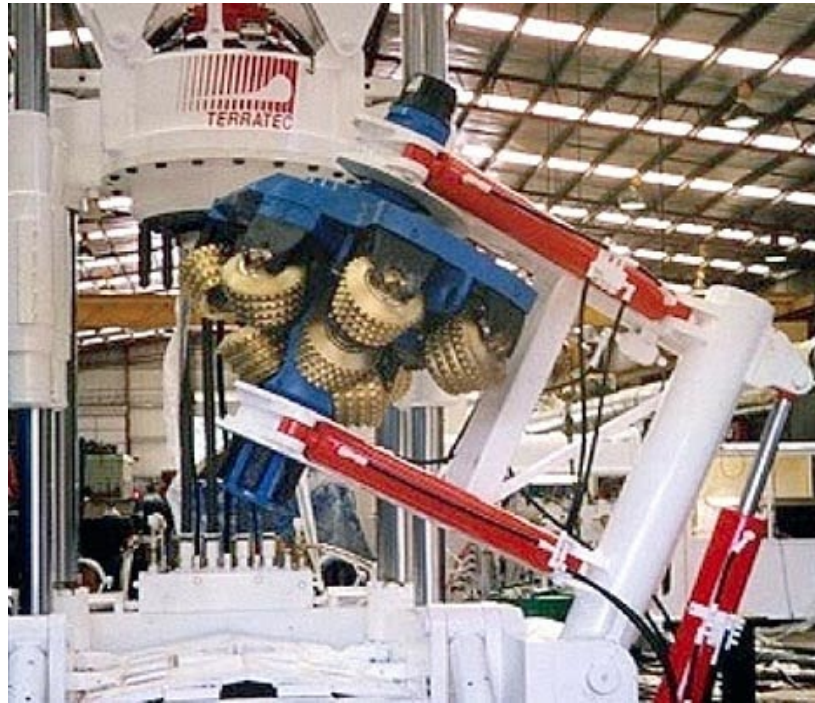
The actual teeth on the bit are specially designed for the rock that the bit will be expected to penetrate, but they are conventionally bit or button teeth, similar in shape to those used in the smaller cones of a conventional oilwell bit.

Reaming head being loaded into place.

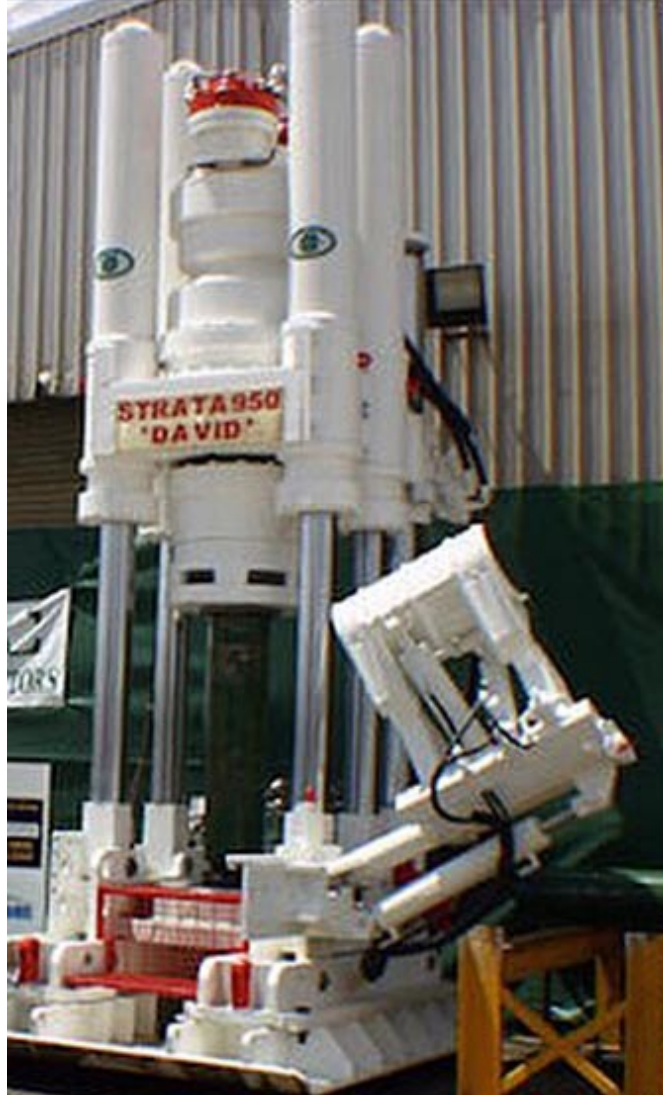
Moving down to Chile, the machine that will be used to drill the relief well is a variant on a raise drilling machine, that is used more commonly for boring holes upwards from the underground space, rather than reaming them down. It is a Strata 950, made by [Murray and Roberts](#) through [RUC Cementation](#). The unit, was, apparently, only built last year.

[The Strata 950.](#)

RUC Cementation has established the capability to design and manufacture specialist large diameter raise borers in its Kalgoorlie workshop. During the year (2009), three Strata 950 raise borers (the most powerful underground raise drill rig in the world) were completed, one for its own use and the other two for group operations in South Africa, Canada and Chile.
