## BP's Deepwater Oil Spill - Capping the Riser - Part 1 (Cap on, but leaks) - and Open Thread

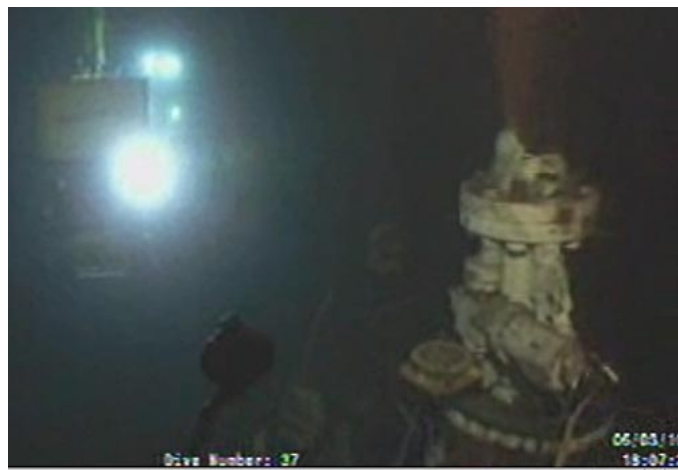
*Lower Riser Assembly (LRA) atop the Blowout Preventer (BOP) at the Deepwater Horizon well, with the bent riser removed, waiting for the arrival of the Lower Marine Riser package (LMRP)*

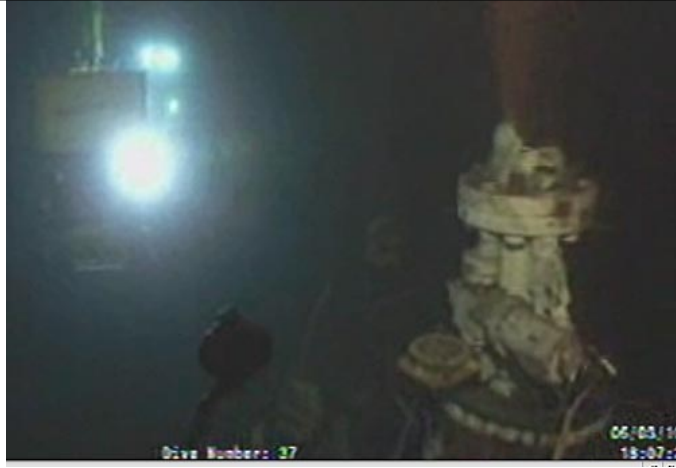
*Lower Riser Assembly (LRA) atop the Blowout Preventer (BOP) at the Deepwater Horizon well, with the bent riser removed, waiting for the arrival of the Lower Marine Riser package (LMRP)*

The oil and gas are rising vertically, from the top of the riser, the drill pipe (DP) and the saw cut in the side of the riser (just down from the top of the shear)

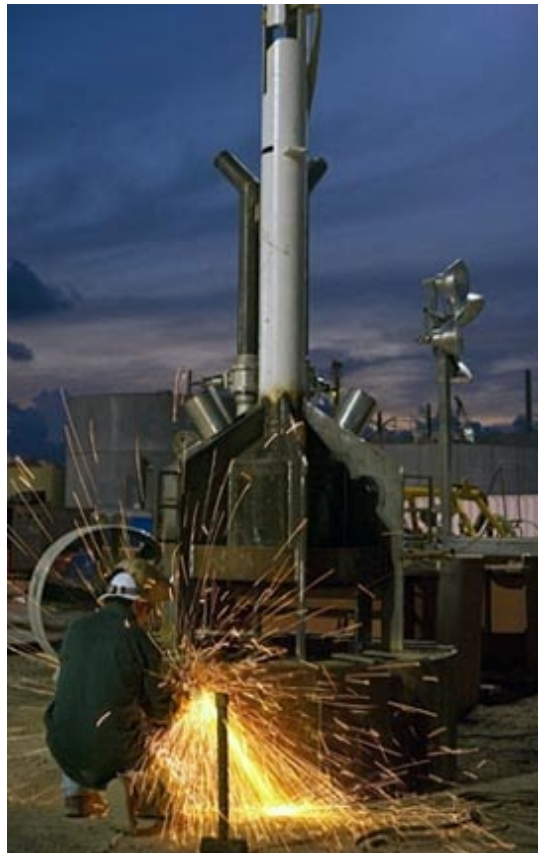
*Building LMRP 7 on June 2nd at Port Fourchon ([BP](#))*

At 8:30 pm, the ROVs maneuvered the latest version of the “top hat”, variation 7, of the LMRP over the top of the LRA. As the new cap was lowered into place, it was surrounded by clouds of oil and gas, making the actual progress of the event somewhat difficult to follow. The new variation had been finished yesterday, to accommodate the changing upper surface of the remnants of the well.

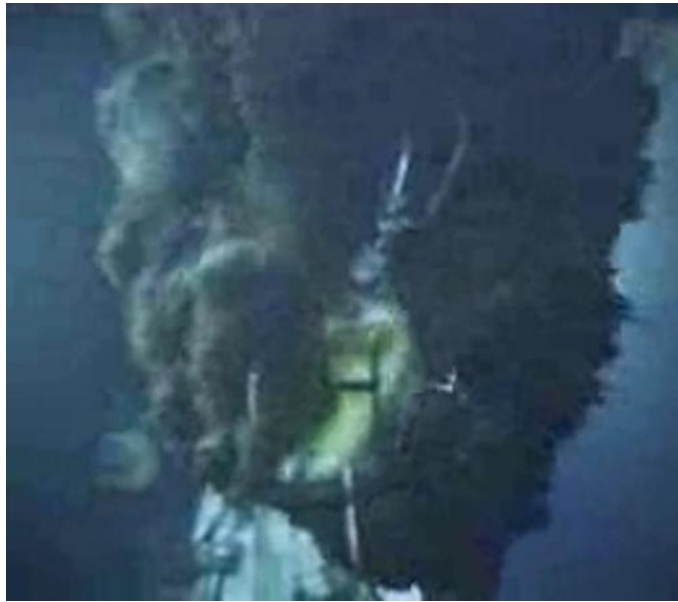
*Lowering the LMRP into the cloud of oil from the riser.*

The Lower Marine Riser Package (LMRP) was first connected to the riser, and to a methanol feed that would help, between them, to inhibit the formation of methane hydrides when the gas came into contact with the surrounding cold seawater. It was then slowly lowered to the site, and across into the fountain of oil and gas, and down over the top of the riser.

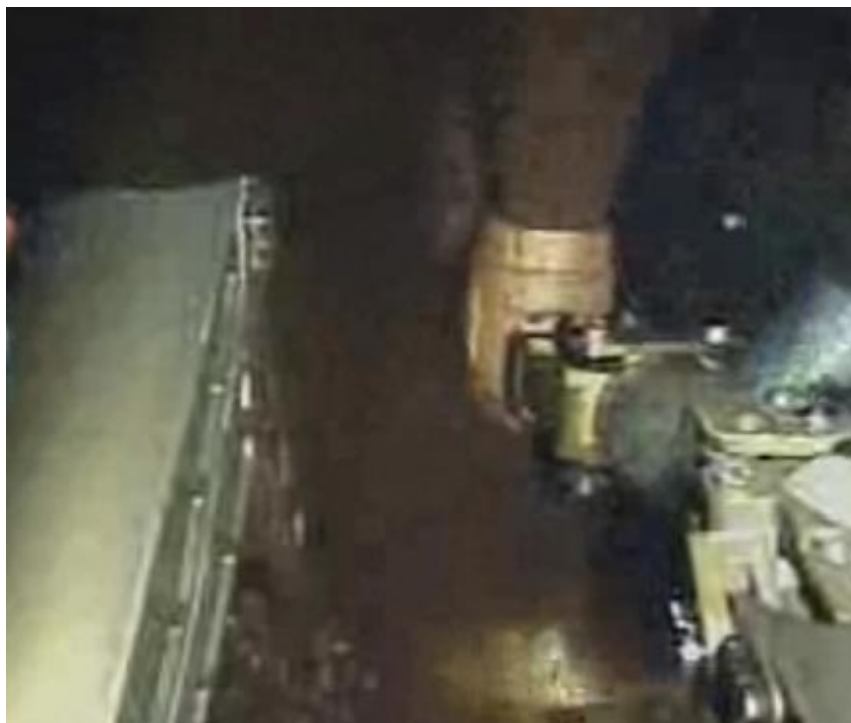
*Flow through a relief port on side off the LMRP to relieve the pressure within it.*

The initial attempt halted after a while, and by 9 pm the situation was, for while static. The cap was sitting apparently on the rubber seal that had been designed to fit between the LMRP and the flange, but the amount of oil that was leaking out of the bottom of the LMRP was still a considerable amount, even though some of the flow was also being bypassed through ports on the LMRP that could later be closed.

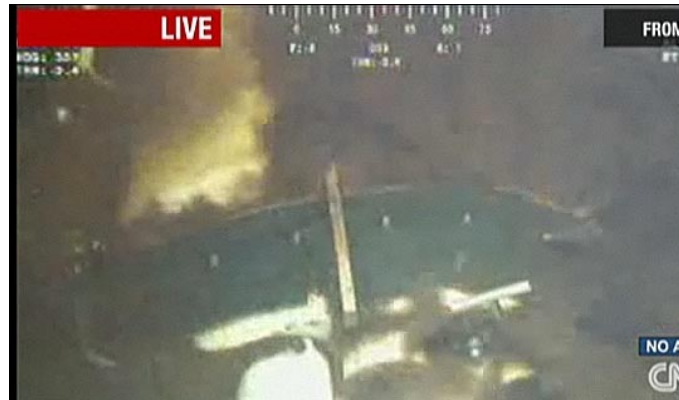
*Leakage around the seal between LMRP 7 (yellow), the seal (greenish black) and the LRA. (white)*

The question now arises as to whether the LMRP could be lowered sufficiently that it could seal to the flange surface, since it was no longer possible to get the seal needed on the upper surface of the riser, given that it had been distorted by the Shear which had cut the bent riser away.

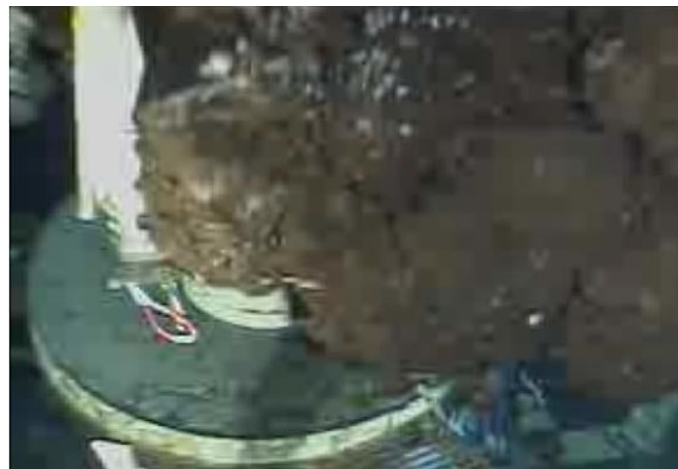
*Oil and gas coming out from under the LMRP*

There was a pause, while the engineers had a bit think for over an hour. Looking at the cloud of oil coming out, it does contain small white specs that could be either methane hydrates or drops of the dispersant. And now, at 10:30 pm, there is a little more action.

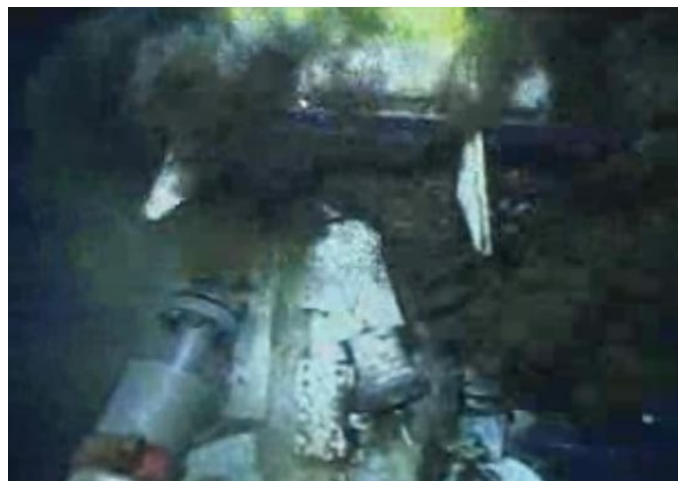
### *Leaks under the LMRP at 10:30 pm*
